CHALK MINE STABILISATION PROJECT HIGHBARNES, HEMEL HEMPSTEAD

Treatment Area 5: 14, 16, 18, 20, 22 & 24 Highbarnes

Report Number: 0013-UA000857-TR-01-TAR-0005

OCTOBER 2015

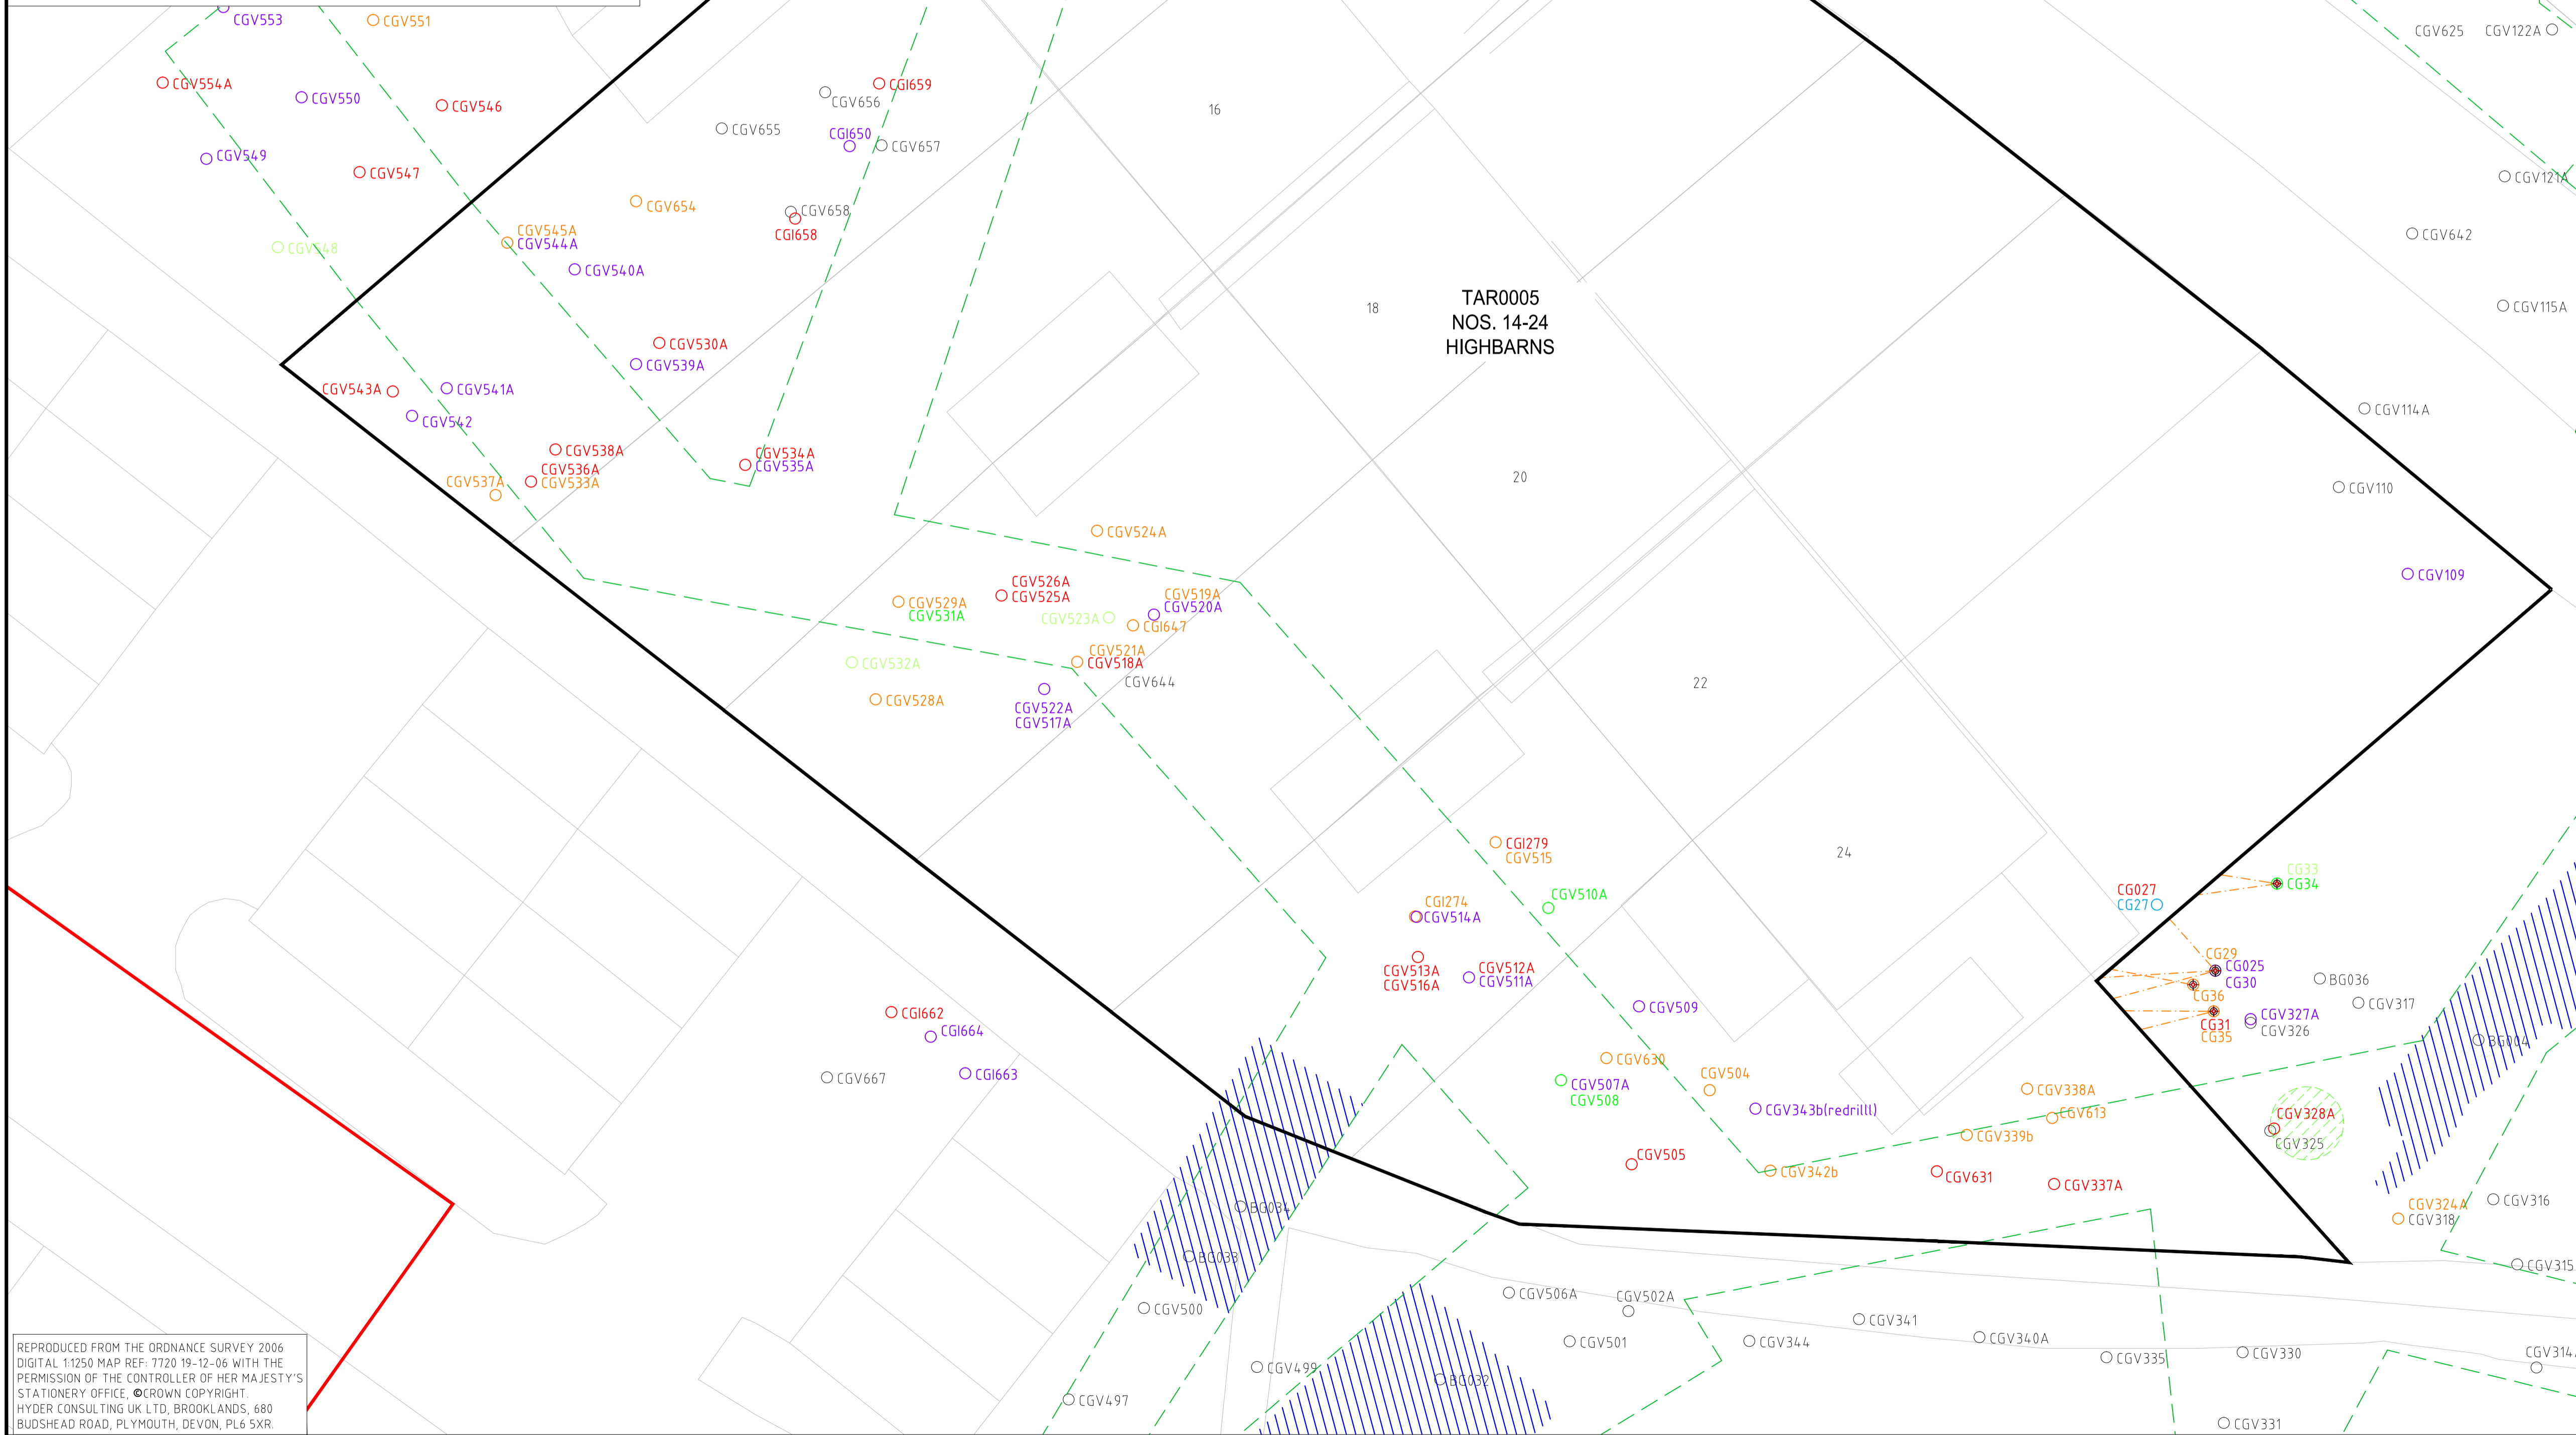
Drawing title: TREATMENT AREA PLAN FOR TAR0005 WITH GROUT HOLES

Treatment works at No. 14 Highbarns were initially concentrated along the anticipated mine gallery along the back garden of the property interpreted from the pre-treatment investigation. Drilling works at location CGV539 identified a void at depths between 14.6m and 19.0m confirming the expected mine depth along the back garden. Several high grout takes at CGV539 (77.2m³) and CGV542 (98.8m³) along the back garden indicated generally open mine workings with subsequent high grout takes at CGV540 (18.0m³) and CGV541 (23.8m³) further suggesting a possible increase in mine extents than previously anticipated.

Due to restrictions in gaining access to the back of the dwelling, this property was grouted using inclined compaction grout holes drilled from the adjacent properties, particularly No. 18 Highbarns. A noticeable increase in grout volumes was observed, with CGV517 (29.8m³), CGV520 (47.2m³) and CGV522 (29.8m³) all inclined from the adjacent property. A reduction in grout volumes was generally observed with successive grouting holes reducing to expected average volumes (CGV519-2.2m³).

Treatment works at No. 22 Highbarns were focused on stabilizing the anticipated mine gallery extending along the back garden. CGV511 (55.7m³) and CGV514 (81.8m³) located along the centre of the expected mine passage confirmed the anticipated mine layout. The high grout volumes suggested treatment of the junction with an east / west trending passageway in the area. Further grout volumes along the back garden were seen to reduce with successive grout holes. A further two inclined grout holes were aimed beneath a detached shed located in the back garden.

The original scope of treatment works was increased due to the volumes of grout injected and the larger than expected mine junction in the back garden. Additional grout holes (CGI662-CGI664) were carried out from the nearby East Green garages to ensure treatment at the mine junction. The high grout takes at CGI663 (38.6m³) and CGI664 (24.9m³) confirmed the need for this further treatment around the mine junction.

Two particularly high grout takes at CGV507 (20.6m³) and CGV509 (15.5m³) were anticipated due to their position close to known open void locations as well as being in close proximity to an anticipated mine junction. Validation probes carried out along the back garden following treatment generally proved that the treatment had improved the relative density of the ground.

Grout hole CGV109 forming part of the scope of works treating the main mine complex at the junction of Highbarns, Pond Road and East Green and located along the front of No. 24 Highbarns had a particularly high grout volume (77.5m³). This was interpreted as indicative of possible further mine workings extending towards the property from the main mine complex. Several rows of dynamic probes were carried out along the front of the property (Phase I works: VP441-445, VP886-887; Phase II works: VPM105-108, VPM149-153) to investigate whether this was a further mine passage extending towards No. 24 Highbarns. The presence of voids in VPM150 confirmed the need for additional treatment along the front of the property. An additional phase of grouting works (CG25, CG27, CG29-CG36) was carried out from an area of public open ground with an initial grout volume observed in CG25 of 14.22m³. Thereafter, successive treatment holes reported a general reduction in grout volumes to generally nominal levels.

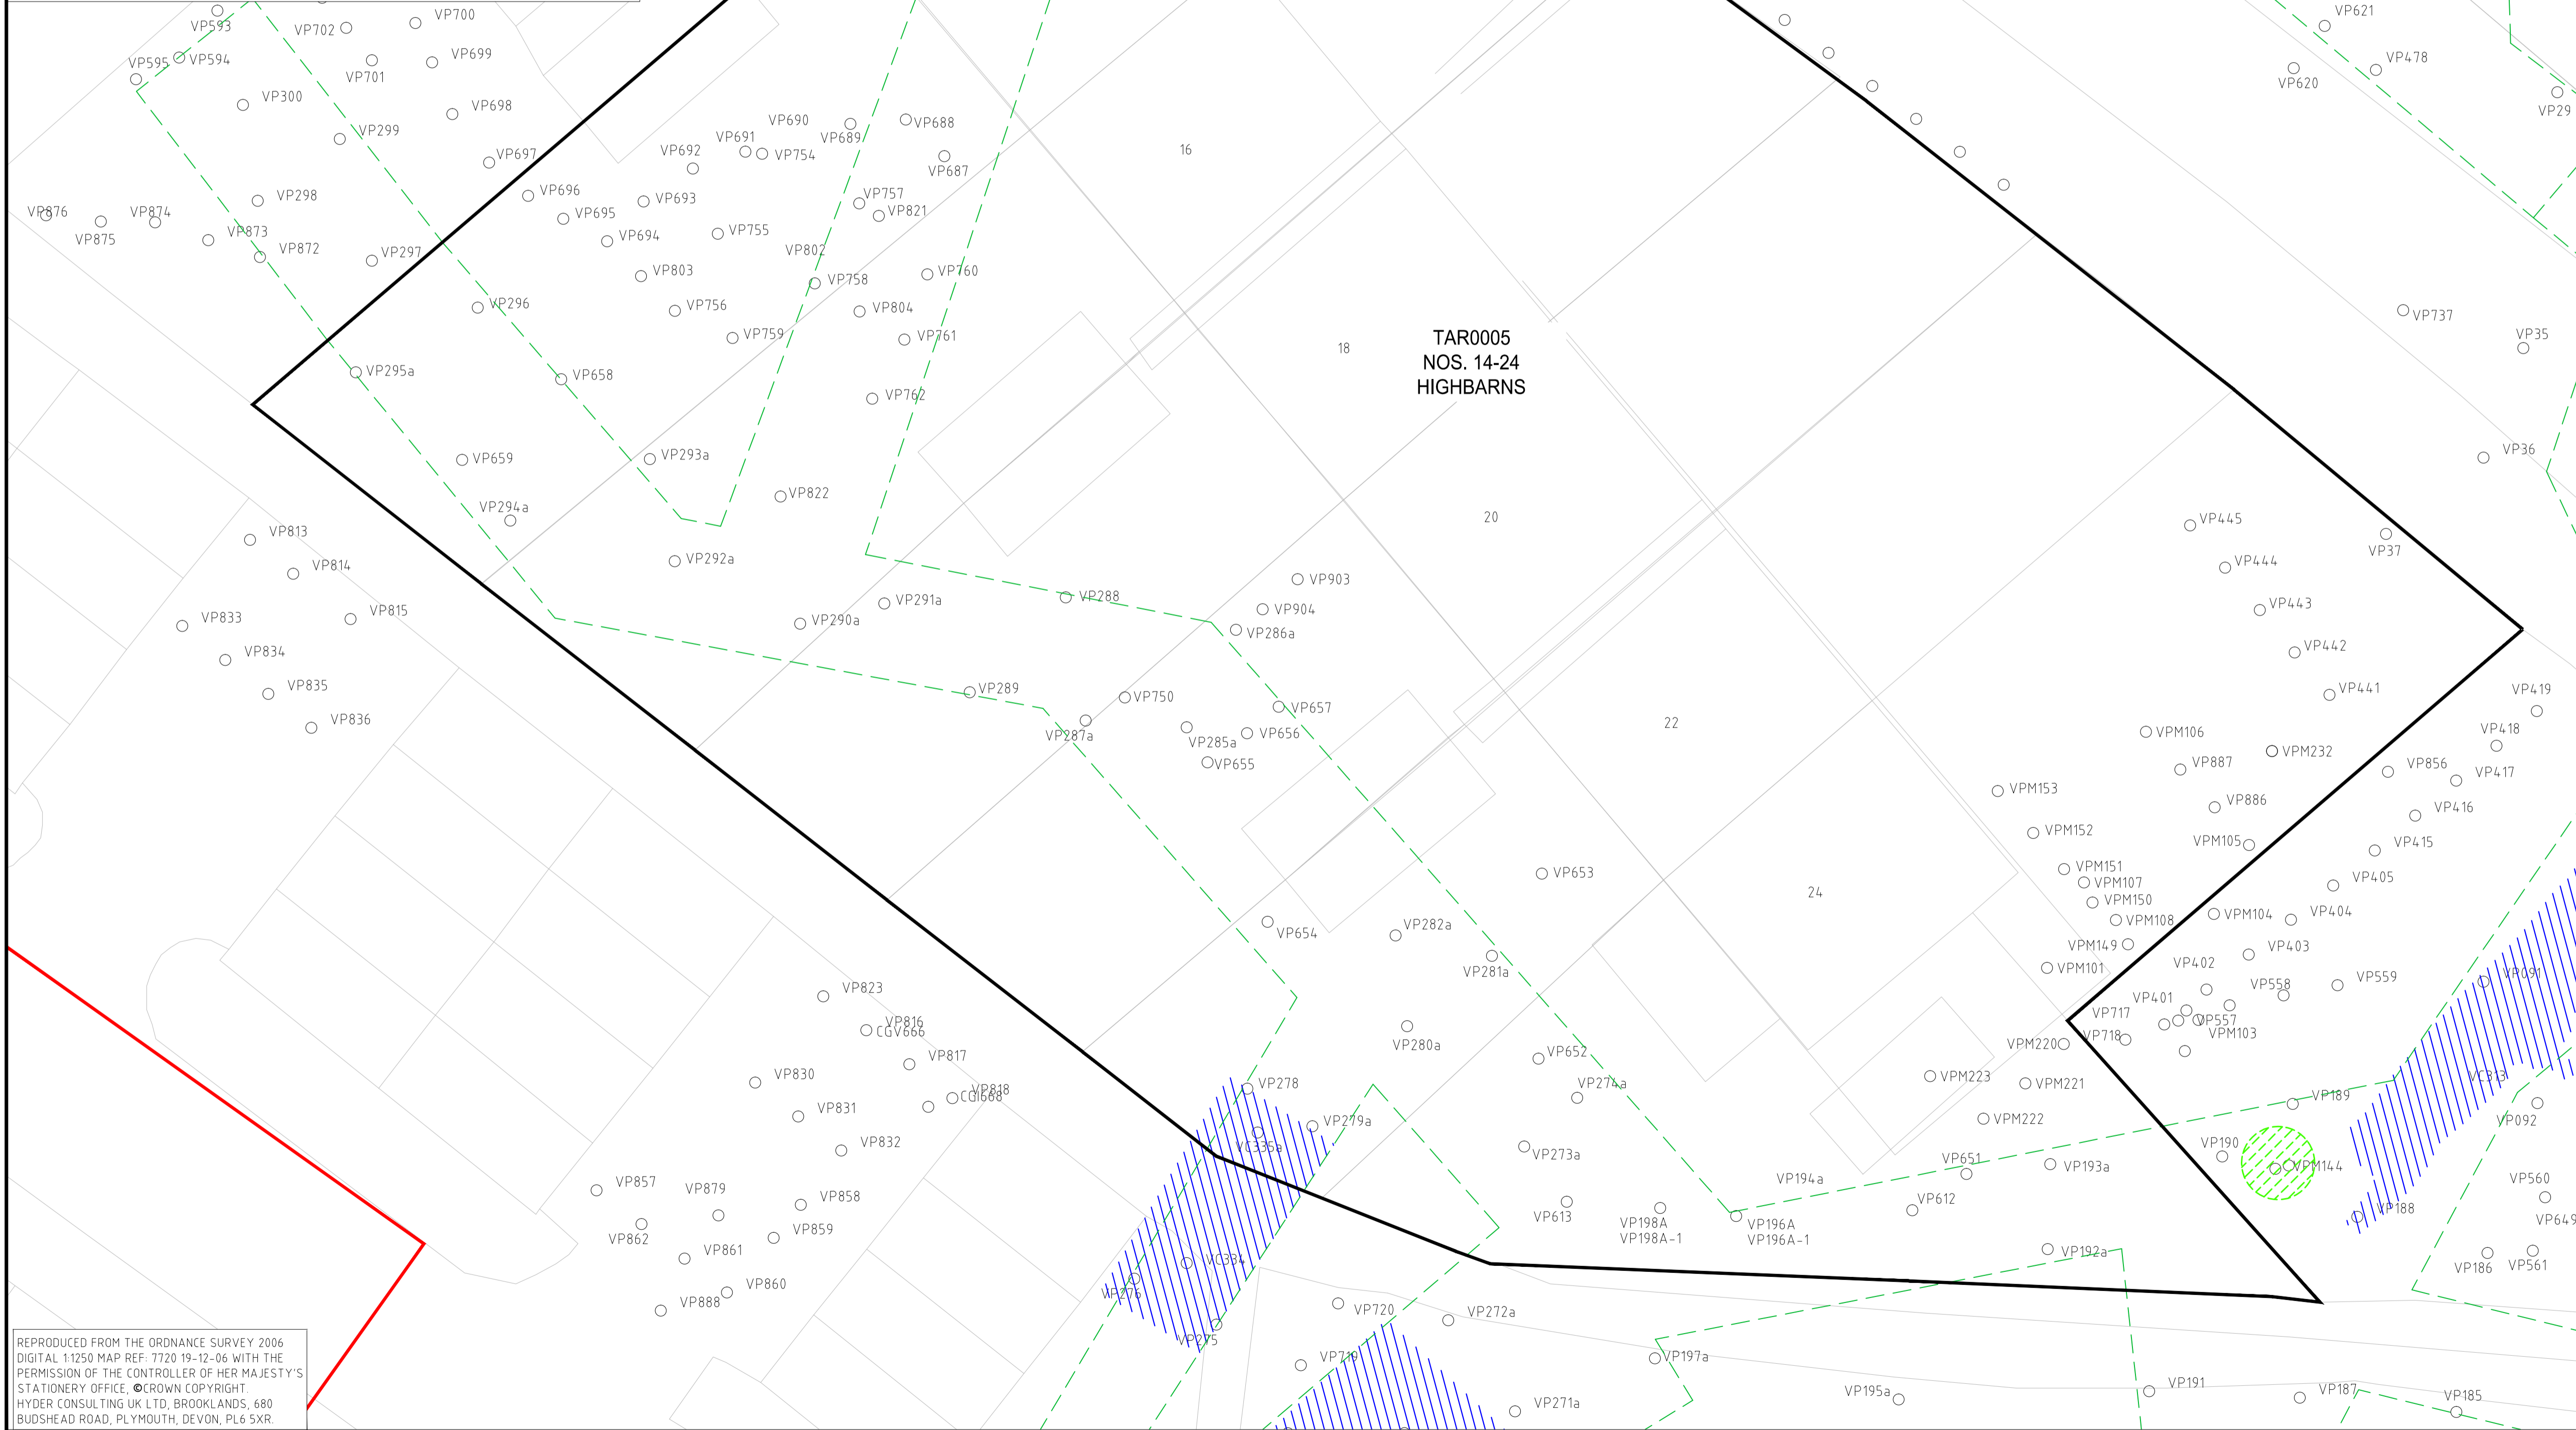
Drawing title: TREATMENT AREA PLAN FOR TAR0005 WITH VALIDATION PROBES

Validation dynamic probing was carried out following the treatment works with two additional dynamic probes (VP658 and VP659) added to the original scope to further validate ground conditions around holes with high grout volumes. Validation probes carried out showed competent ground conditions at the anticipated mine depths. Validation probes carried out along the back garden to validate the area of previously unknown treatment (VP754-VP759) also recorded competent ground conditions following treatment outside the original mine extents.

Validation dynamic probing (VP287a-VP291a) carried out along the mine gallery following the completion of treatment works did not record conditions that would suggest residual untreated mine ground.

Validation dynamic probing was carried out following completion of the design grout works. However, validation probes VP285a and VP286a uncovered evidence of weak ground close to ground level. A further three validation dynamic probes were carried out, with VP655 – VP657 confirming this was not an isolated ground feature. An additional two grout holes were undertaken from No. 18 Highbarns, with CGV644 (2.7m³) and CGI647 (2.03m³) aimed to treat any remaining mining-related disturbed ground closer to ground level. Further validation probing was carried out to confirm that no residual weakness remained following treatment (VP750) as well as to ensure that no additional mine workings extended towards the main property (VP903 – VP904). These validation dynamic probes did not reveal evidence of mined ground.

Grouting volumes along the side of No. 24 Highbarns were generally recorded as nominal but validation probing, carried out in the area following treatment, uncovered evidence of untreated ground at VP612 particularly at depths between 16m and 18m bgl. An additional validation dynamic probe, VP651, did not confirm this and it is thought that the results indicate only localized weak ground.
