CHALK MINE STABILISATION PROJECT HIGHBARNNS, HEMEL HEMPSTEAD

Treatment Area 11: Nos. 2, 4, 6 and 8 Meadow Road

Report Number: 0013-UA000857-TR-01-TAR-0011

OCTOBER 2015

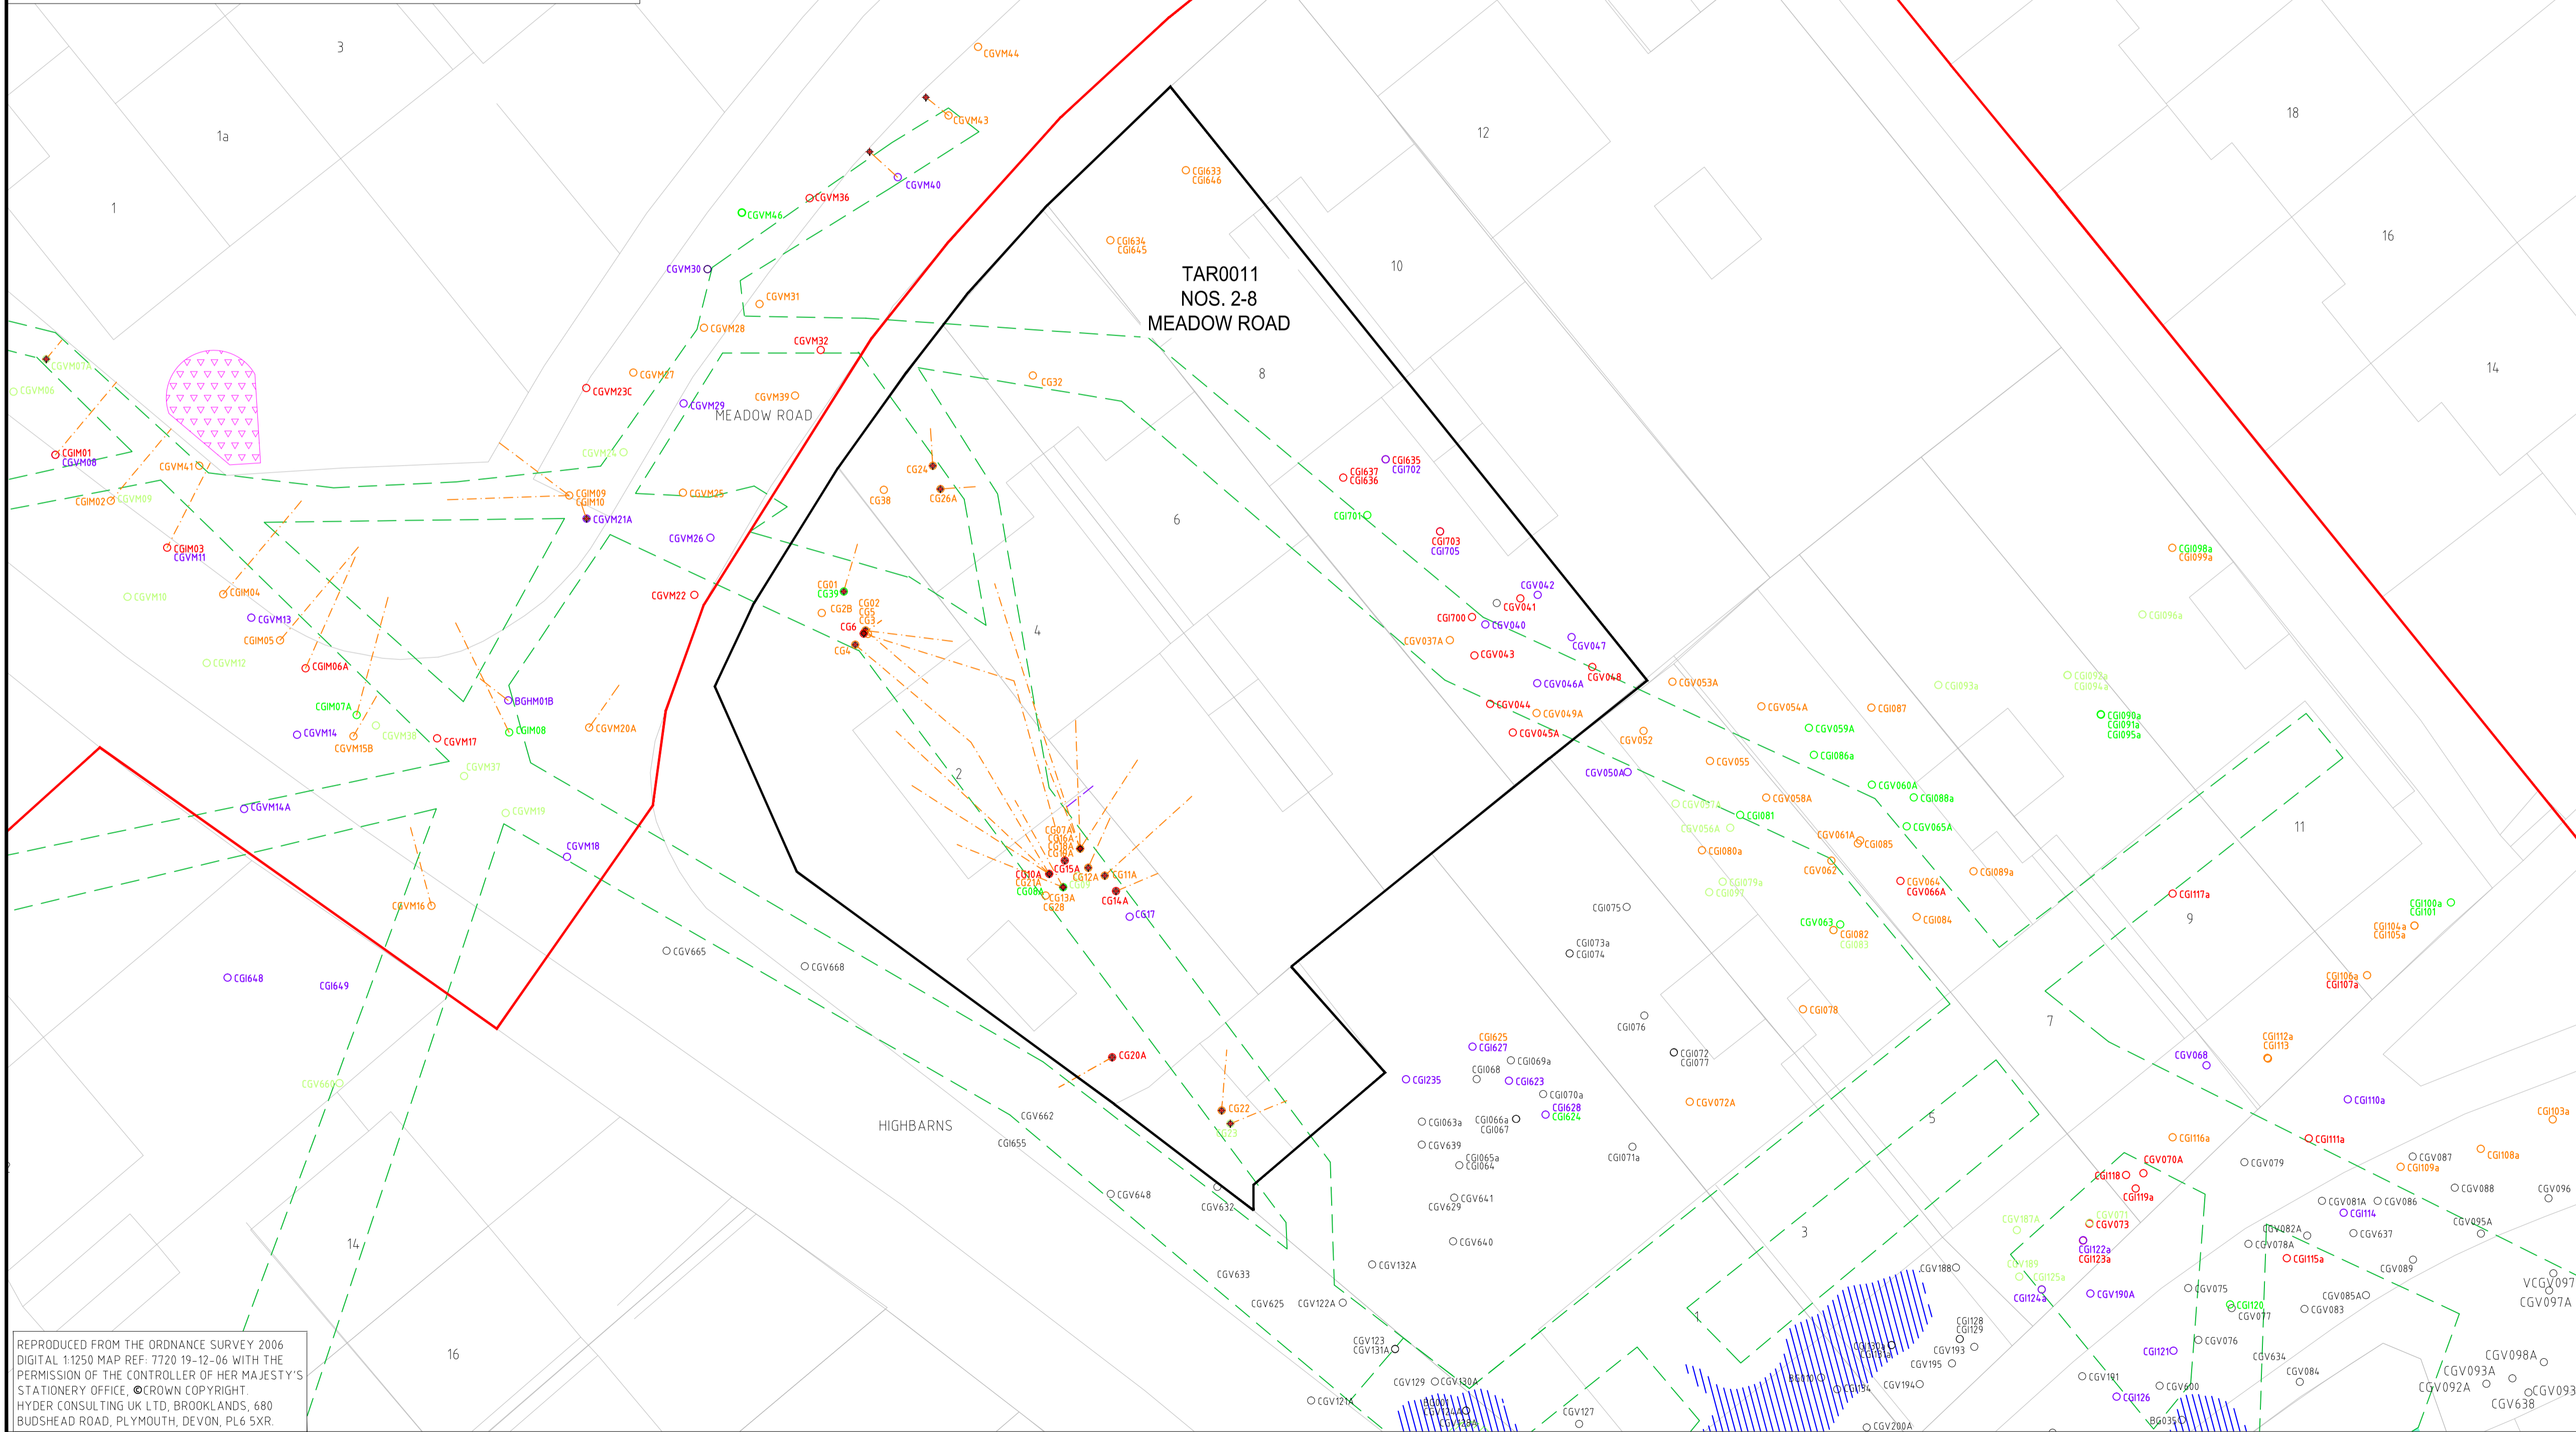
**Drawing TA0011-01 – Treatment Area Plan for TAR0011
with Grout Holes**

A total grout volume of 91.0m³ was injected into seventeen inclined and vertical compaction grout holes located in the front and rear gardens of No. 2 Meadow Road. This confirmed the presence of mined ground beneath the property. A maximum grout volume of 32.7m³ was injected into CG17 located in the rear garden of No. 2. This was one of the first grout holes to be completed in the area with volumes seen to consistently reduce in subsequent grout holes as the treatment progressed. This was the expected outcome of the grouting works demonstrating that treatment of the mined ground was taking place.

A total grout volume of 42.295m³ was injected into ten inclined and vertical compaction grout holes located in the front and rear gardens of No. 4 Meadow Road or drilled from adjacent properties. The volumes of grout injected into these holes were not considered indicative of significant open mine workings. CG06 had the highest grout volume (7.3m³) and was within the interpreted mine layout beneath the property.

A grout volume of 4.921m³ was injected into a single vertical compaction grout hole CG32 located in the front garden of No. 6. The grout volumes were not indicative of open mine workings.

A maximum grout volume of 77.4m³ was injected into CGV046A located in the rear garden of No. 8. This was one of the first grout holes to be completed in the area with volumes seen to consistently reduce in subsequent grout holes as the treatment progressed. Overall a total of 240.5m³ of grout was injected into twenty three inclined and vertical compaction grout holes located in the front and rear gardens of No. 8 Meadow Road. This confirmed the presence of mined ground beneath the property. Validation probes completed in the front and back gardens and one internal probe within the house did not reveal residual weak ground that would be indicative of untreated collapsed mine workings.

A grout volume of 3.9m³ was injected into vertical compaction grout hole CG22 located in front of Highbarns Garages, in the southern corner of the treatment area. A total of five validation probes (VPM144 to VPM193) to depths ranging between 11.9m

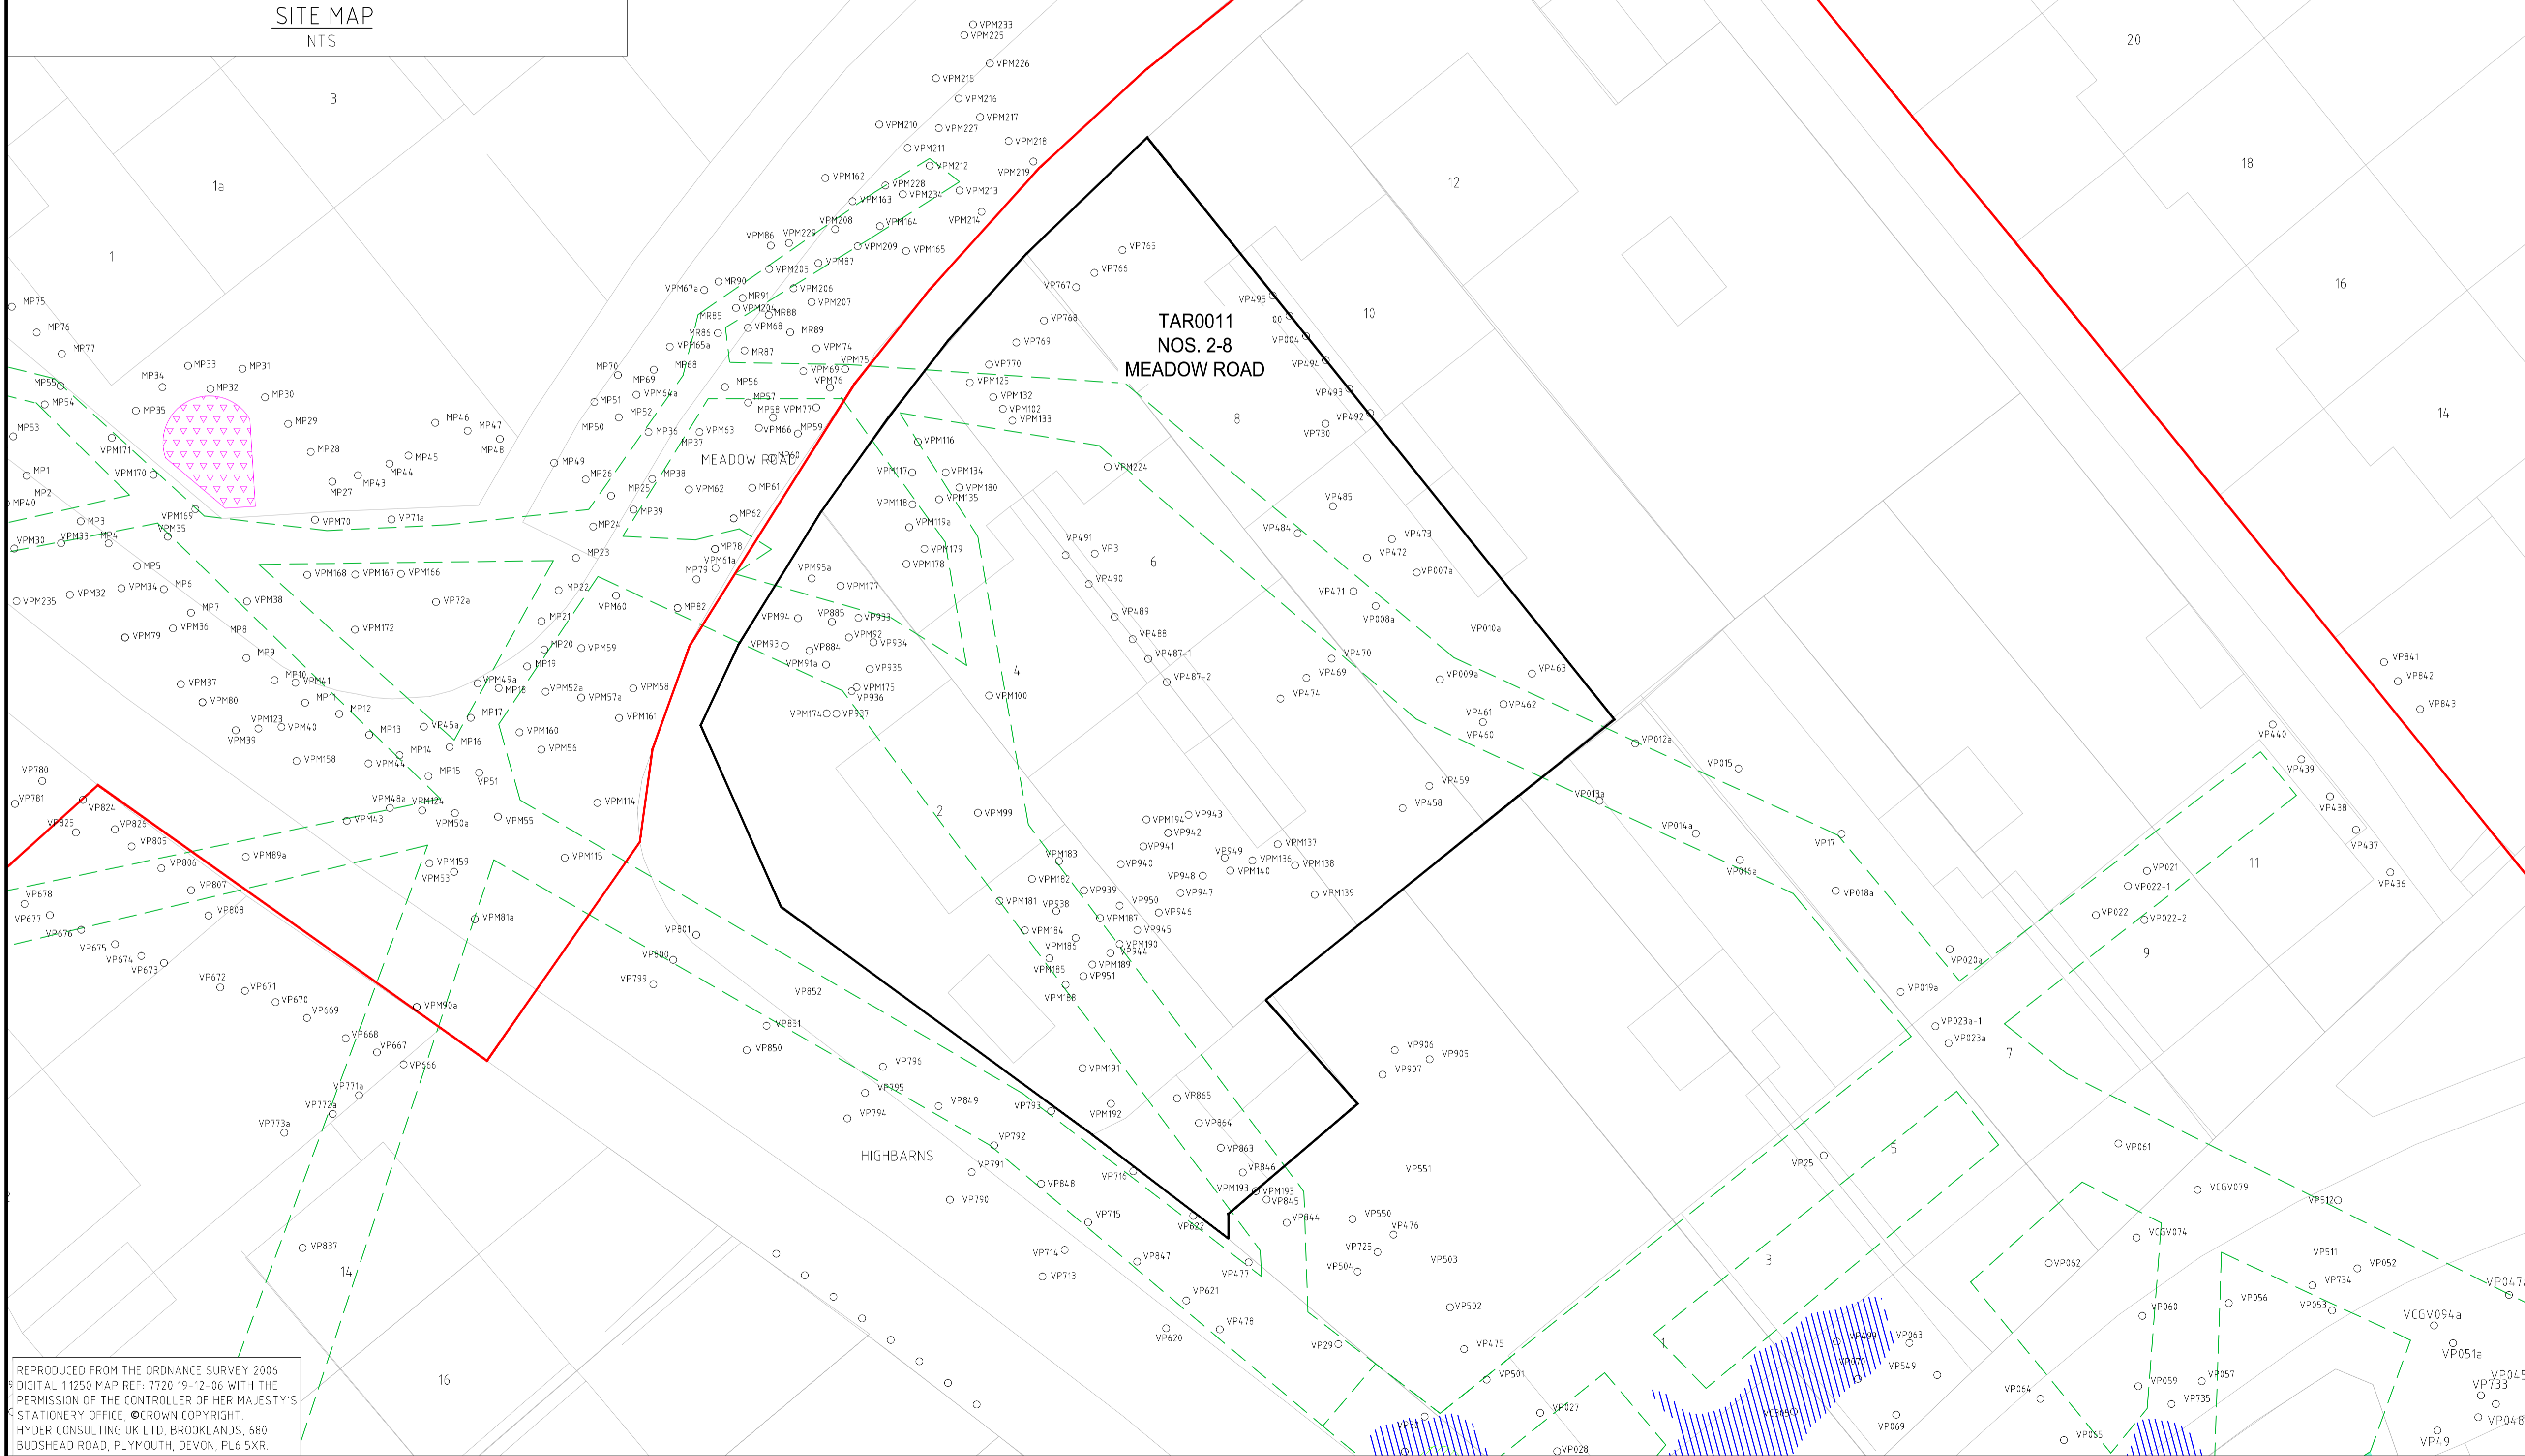
**Drawing TA0011-02 - Treatment Area Plan for TAR0011
with Validation Probes**

Validation probes (VPM91 to VPM190) to depths ranging between 9.6m and 18.0m were undertaken in the front and rear gardens of No. 2 Meadow Road. The validation probe results did not show any residual weak ground that would be indicative of untreated collapsed mine workings.

Validation probes to depths ranging between 9.0m and 20.7m were undertaken in the front and rear gardens of No. 4 Meadow Road following treatment. The validation probe results did not show any residual weak ground that would be indicative of untreated collapsed mine workings.

Subsequent validation probes VP768-VP770 completed following treatment in December 2013 did not show any mining related disturbed ground. Following further treatment at adjacent properties, a further five validation probes were completed within the area of the interpreted mine layout and these did not show any weak ground that may be mining related.

and 19.0m were subsequently undertaken adjacent to Highbarns Garages. The validation probe did not indicate any residual weak ground that may be indicative of untreated mine workings.
