CHALK MINE STABILISATION PROJECT HIGHBARNNS, HEMEL HEMPSTEAD

Treatment Area 6: Nos. 30 and 32 Highbarnns

Report Number: 0013-UA000857-TR-01-TAR-0006

OCTOBER 2015

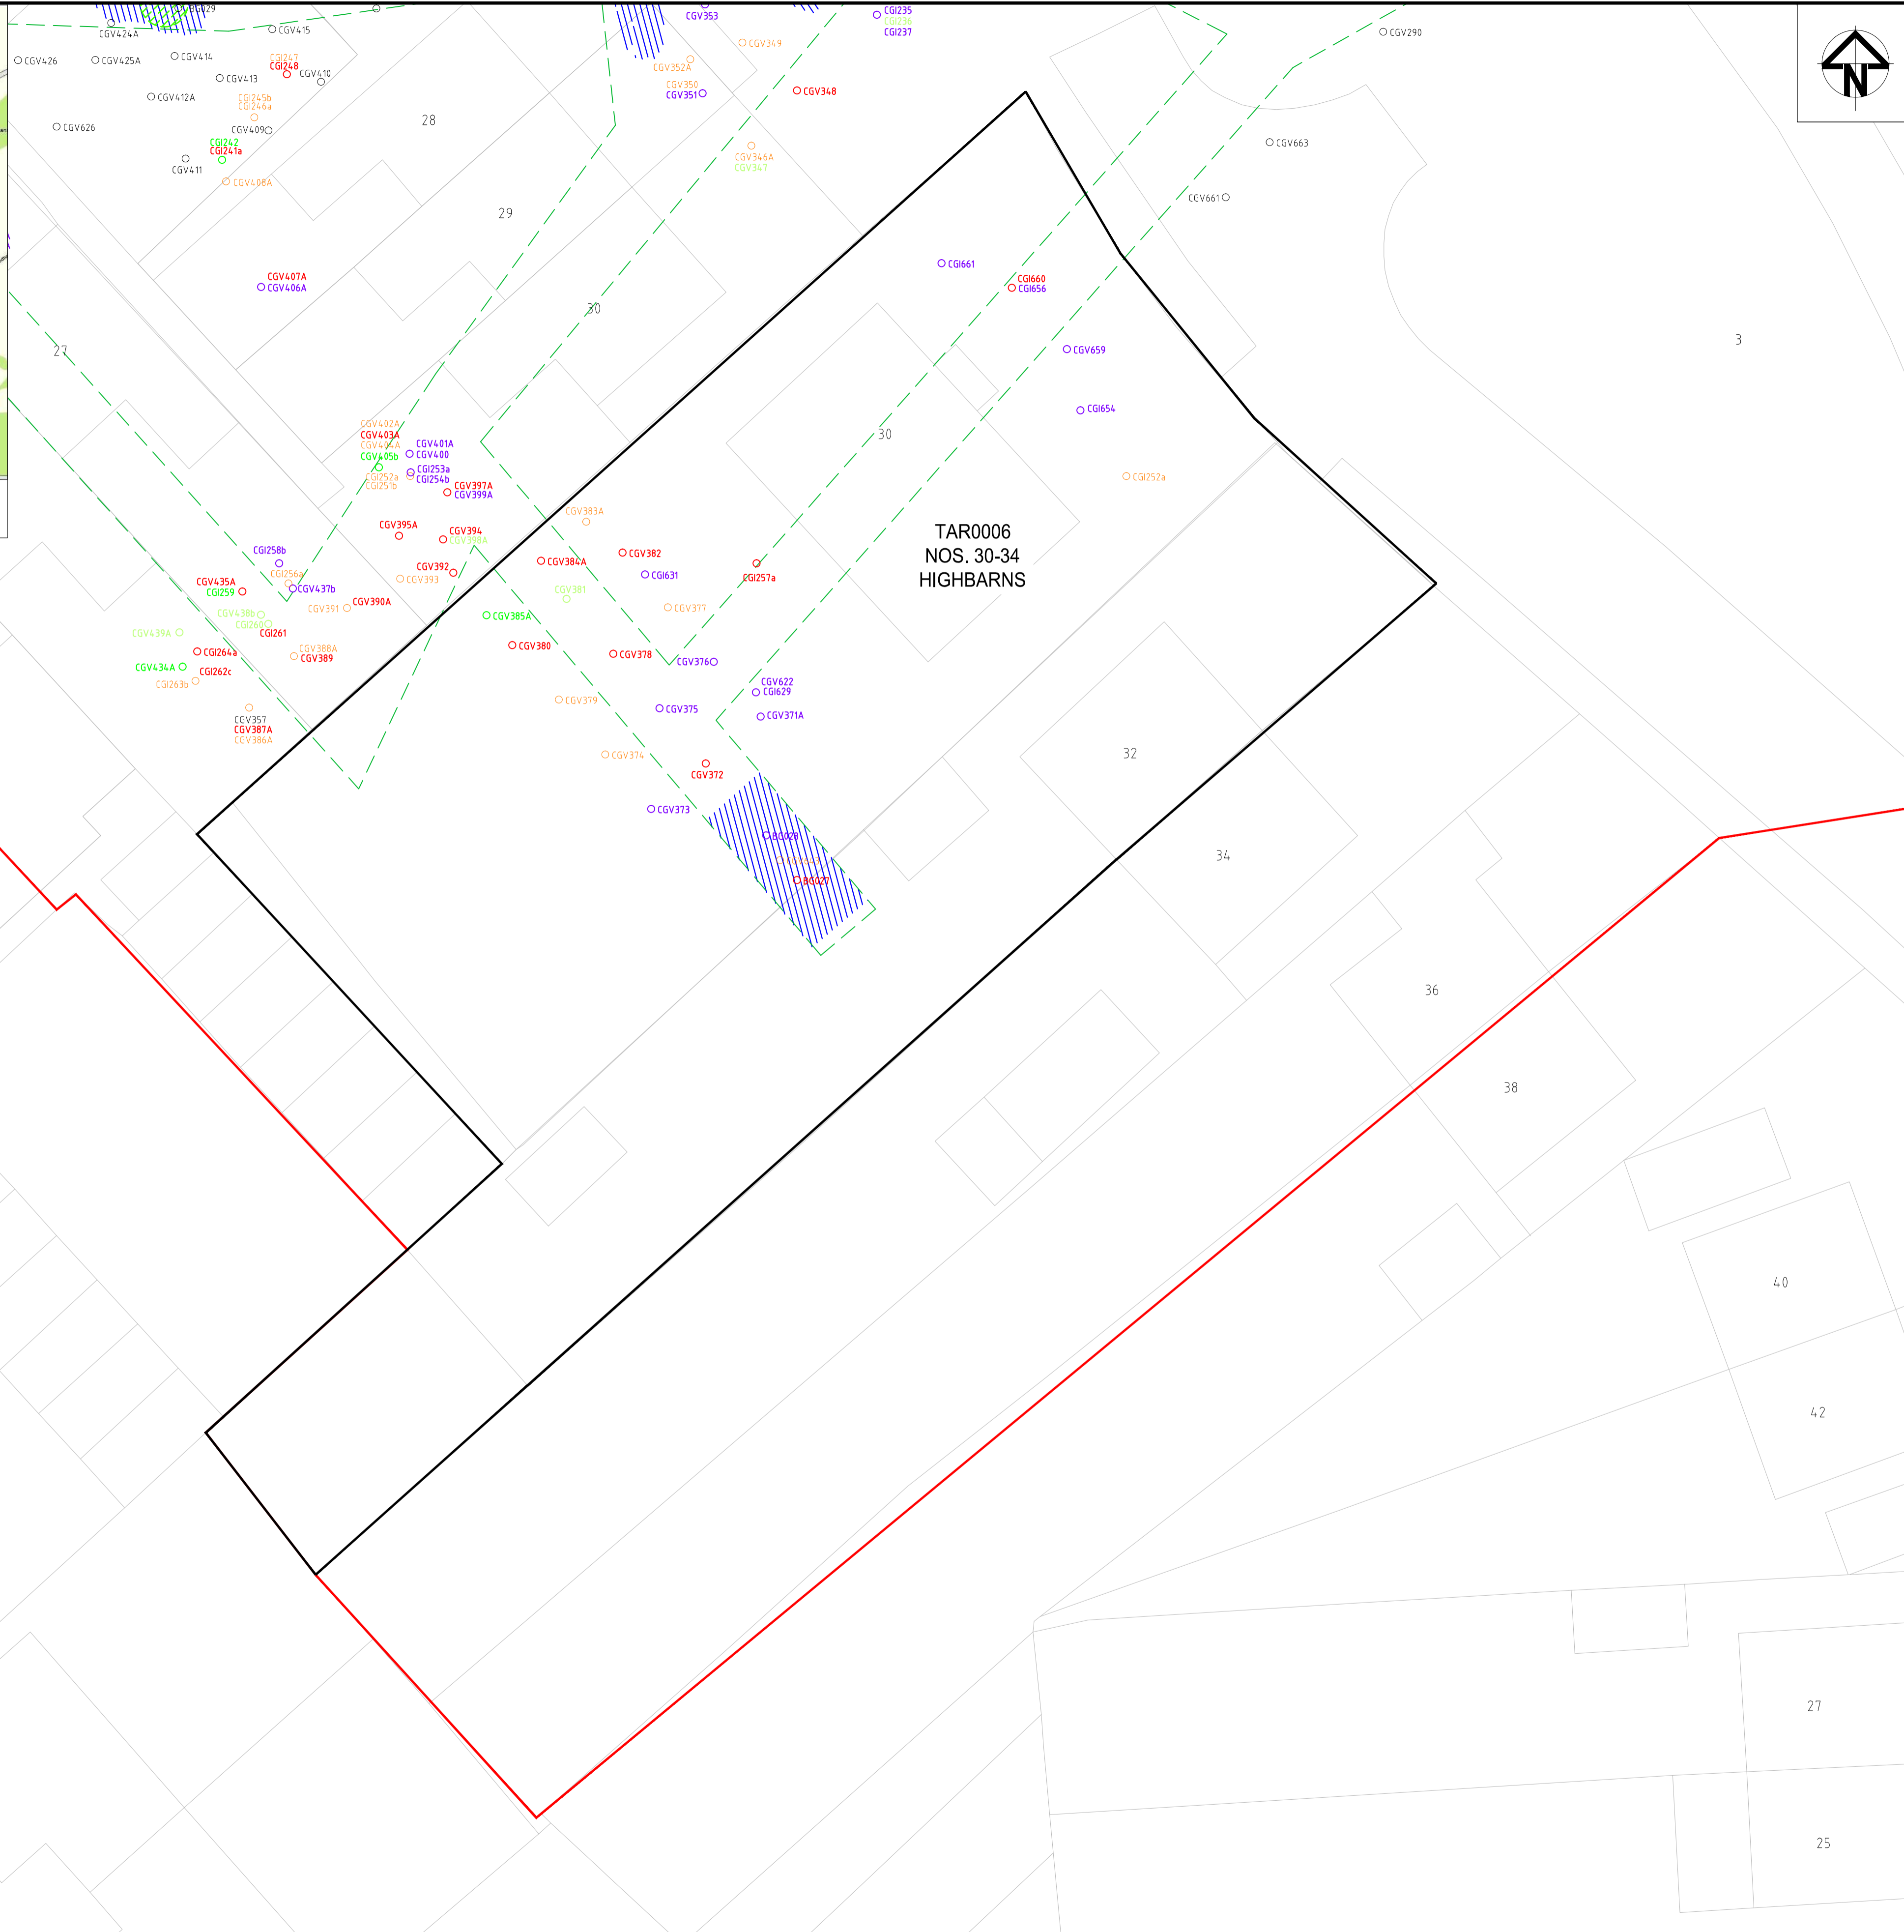
Drawing title: TREATMENT AREA PLAN
FOR TAR0006
WITH GROUT HOLES

Treatment works at No. 30 Highbarns commenced with bulk infilling at the location identified as possible voids related to mining assessed from the pre-treatment ground investigation. The resultant grout volumes at BG027 (5.5m³) and BG028 (40.2m³) confirmed poor ground along the back garden of the property. Planned treatment along the back garden also confirmed the presence of a mine junction with high grout volumes at CGV375 (120m³), CGV371A (36m³) and CGV376 (30.6m³).

Further investigative probing (VP505 – VP510) and subsequent grouting at CGI629 (69.7m³) and CGV622 (103m³) close to the property confirmed a mine passage extending from the mine junction heading towards the property. A row of dynamic probes carried out along the front of the property uncovered further evidence of voided ground at VP745. Grouting at probe location VP745 resulted in a total grout volume at CGV655 of 124.06m³ and was similar to the volumes injected at the front of the property. Further inclined grouting aimed beneath the property was carried out to ensure complete the treatment at No. 30 Highbarns.

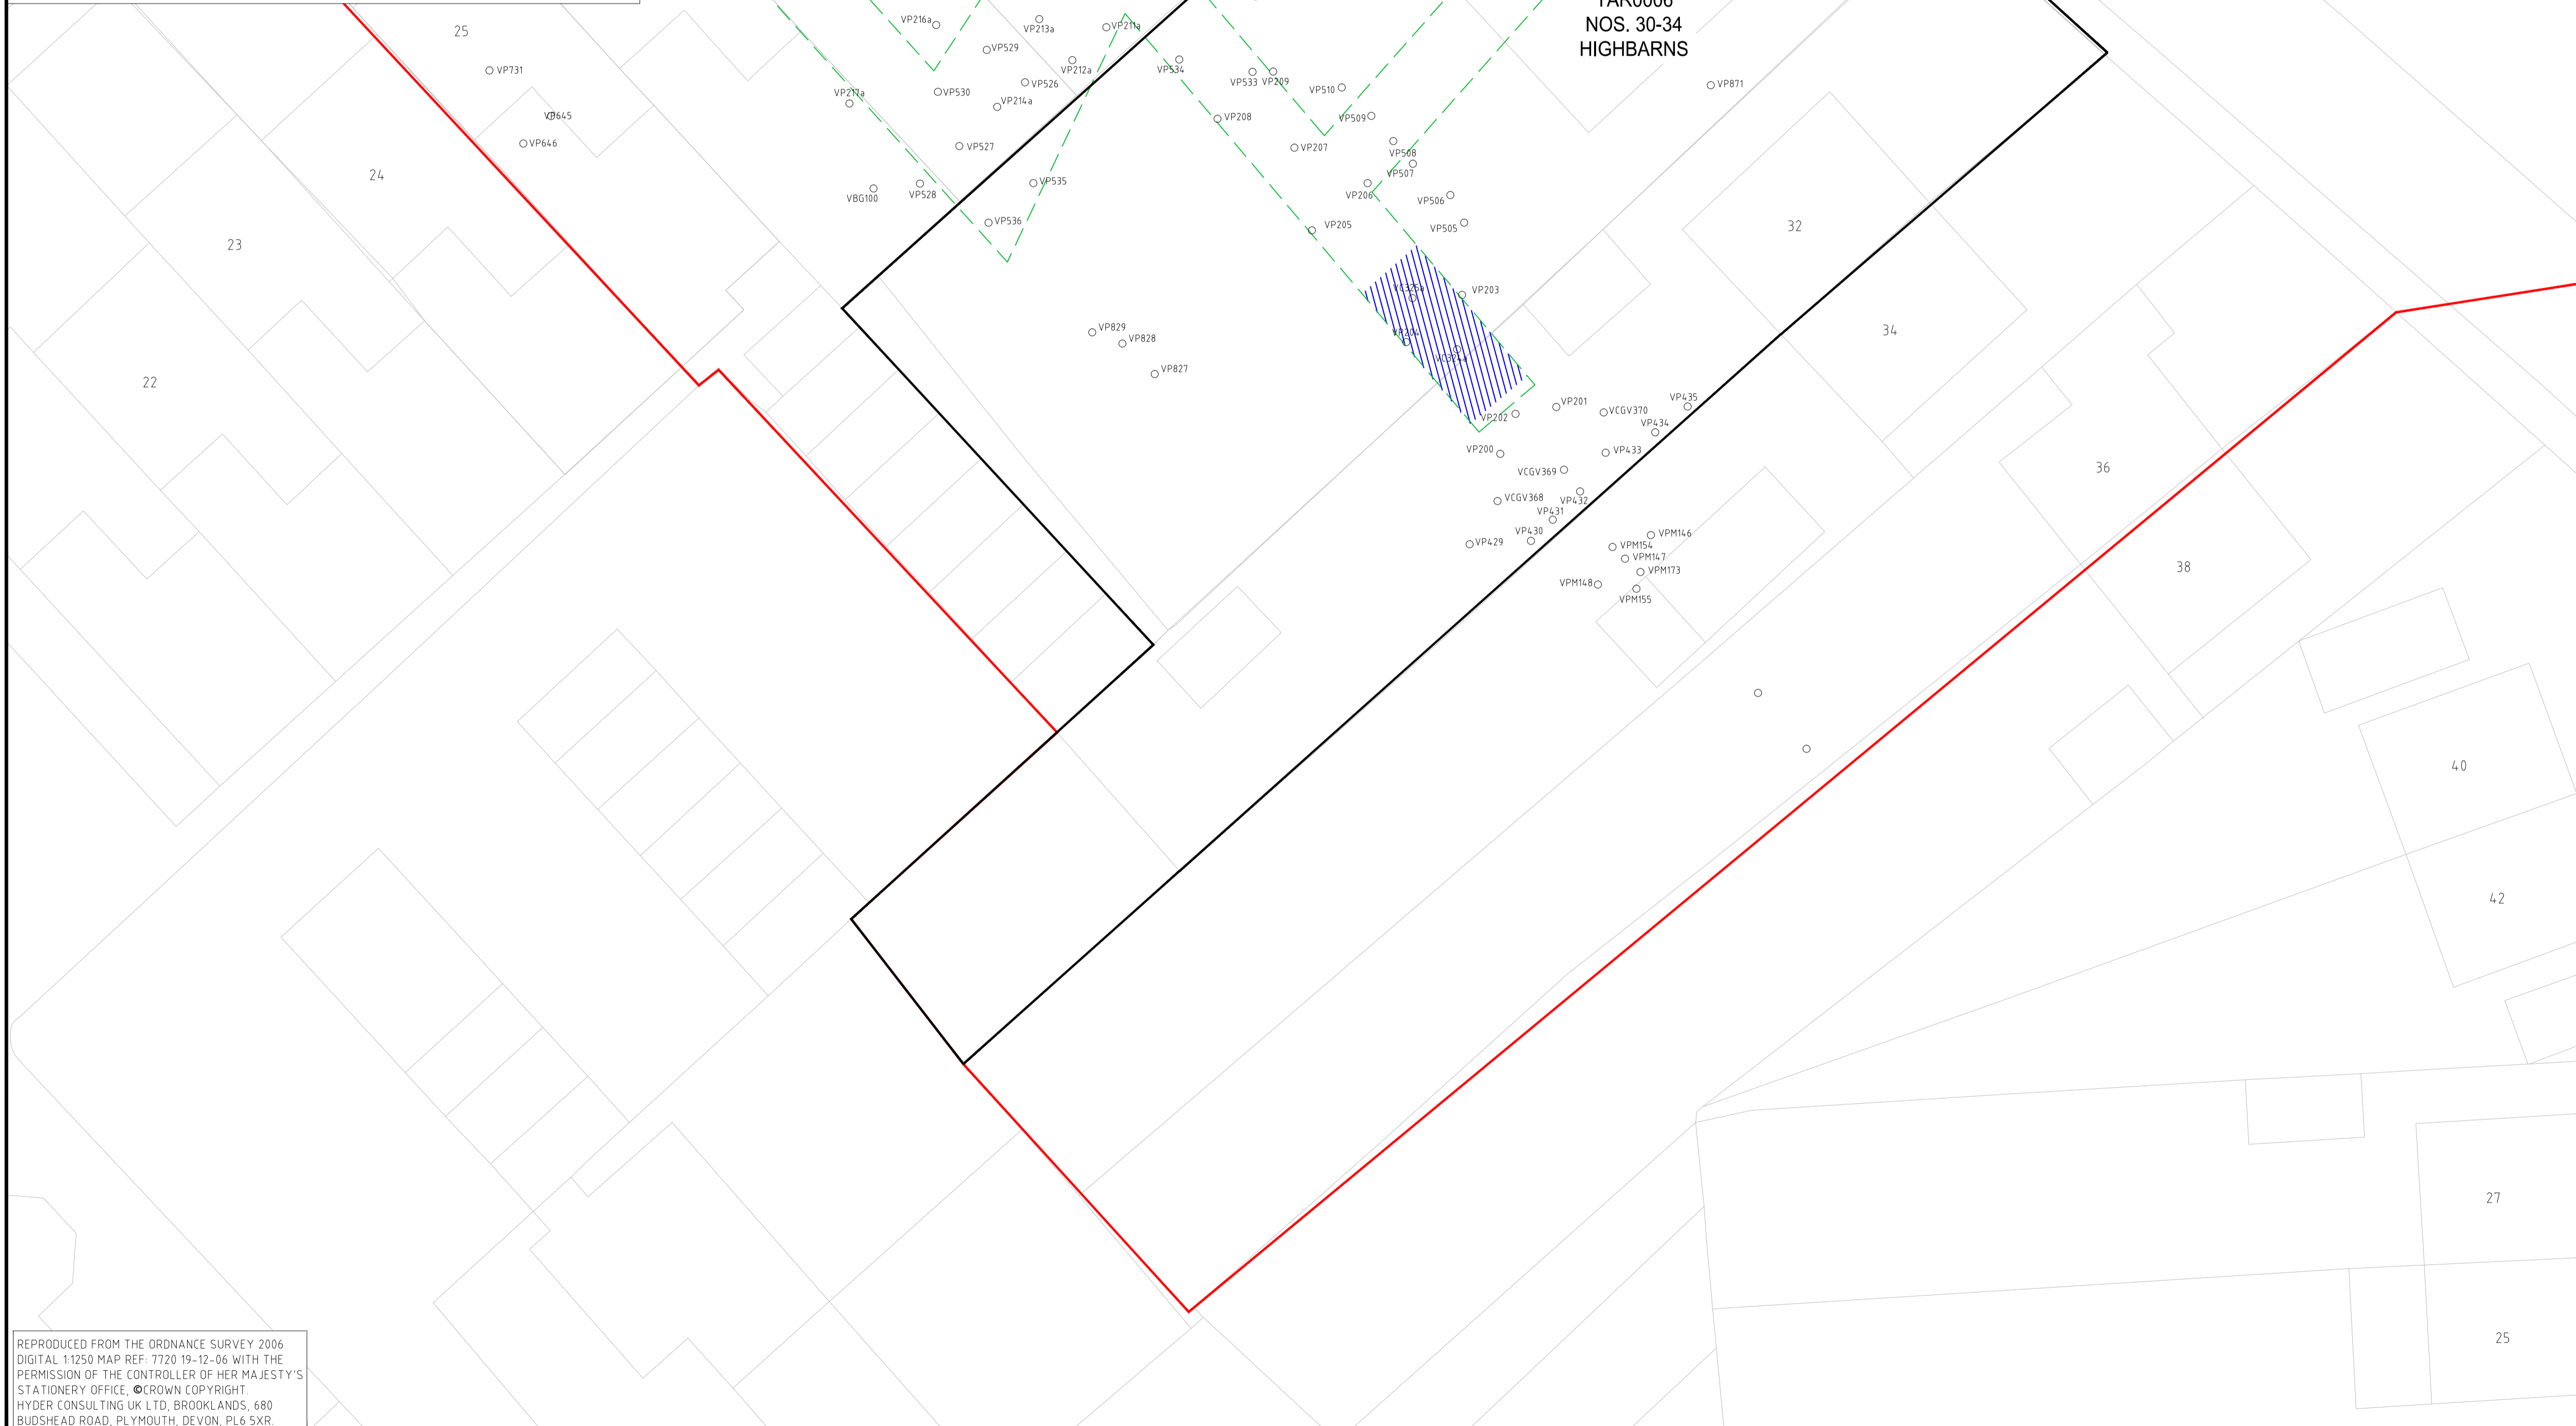
Drawing title: TREATMENT AREA PLAN
FOR TAR0006
WITH VALIDATION PROBES

The conclusions of the grouting and validation probing at No 30 Highbarns indicated that the mine did not extend beyond the boundary of No 30. While it was original planned to carry out treatment works along the back garden of No. 32, these were replaced with several rows of dynamic probing. No of these successive rows of dynamic probing indicated weak ground that would be indicative of collapsed mining as and a consequence no grouting was deemed necessary.

Further dynamic probing was undertaken along the back garden of No. 34 Highbarns to investigate cracking to a temporary structure located in the back garden. Initial dynamic probing in the area failed to penetrate down to the suspected depth of mine workings in the area.

Subsequent dynamic probing (VPM147, VPM154, VPM155) located along the anticipated mine gallery extents were all found to terminate at the suspected mine roof depth (around 12m bgl). A final dynamic probe, VPM173, managed to penetrate through the anticipated mine depth and did not reveal any weak ground that would be indicative of collapsed mine workings.
