CHALK MINE STABILISATION PROJECT HIGHBARNS, HEMEL HEMPSTEAD

Treatment Area 9: Nos. 5, 7, 9 and 11 Pond Road

Report Number: 0013-UA000857-TR-01-TAR-0009

OCTOBER 2015

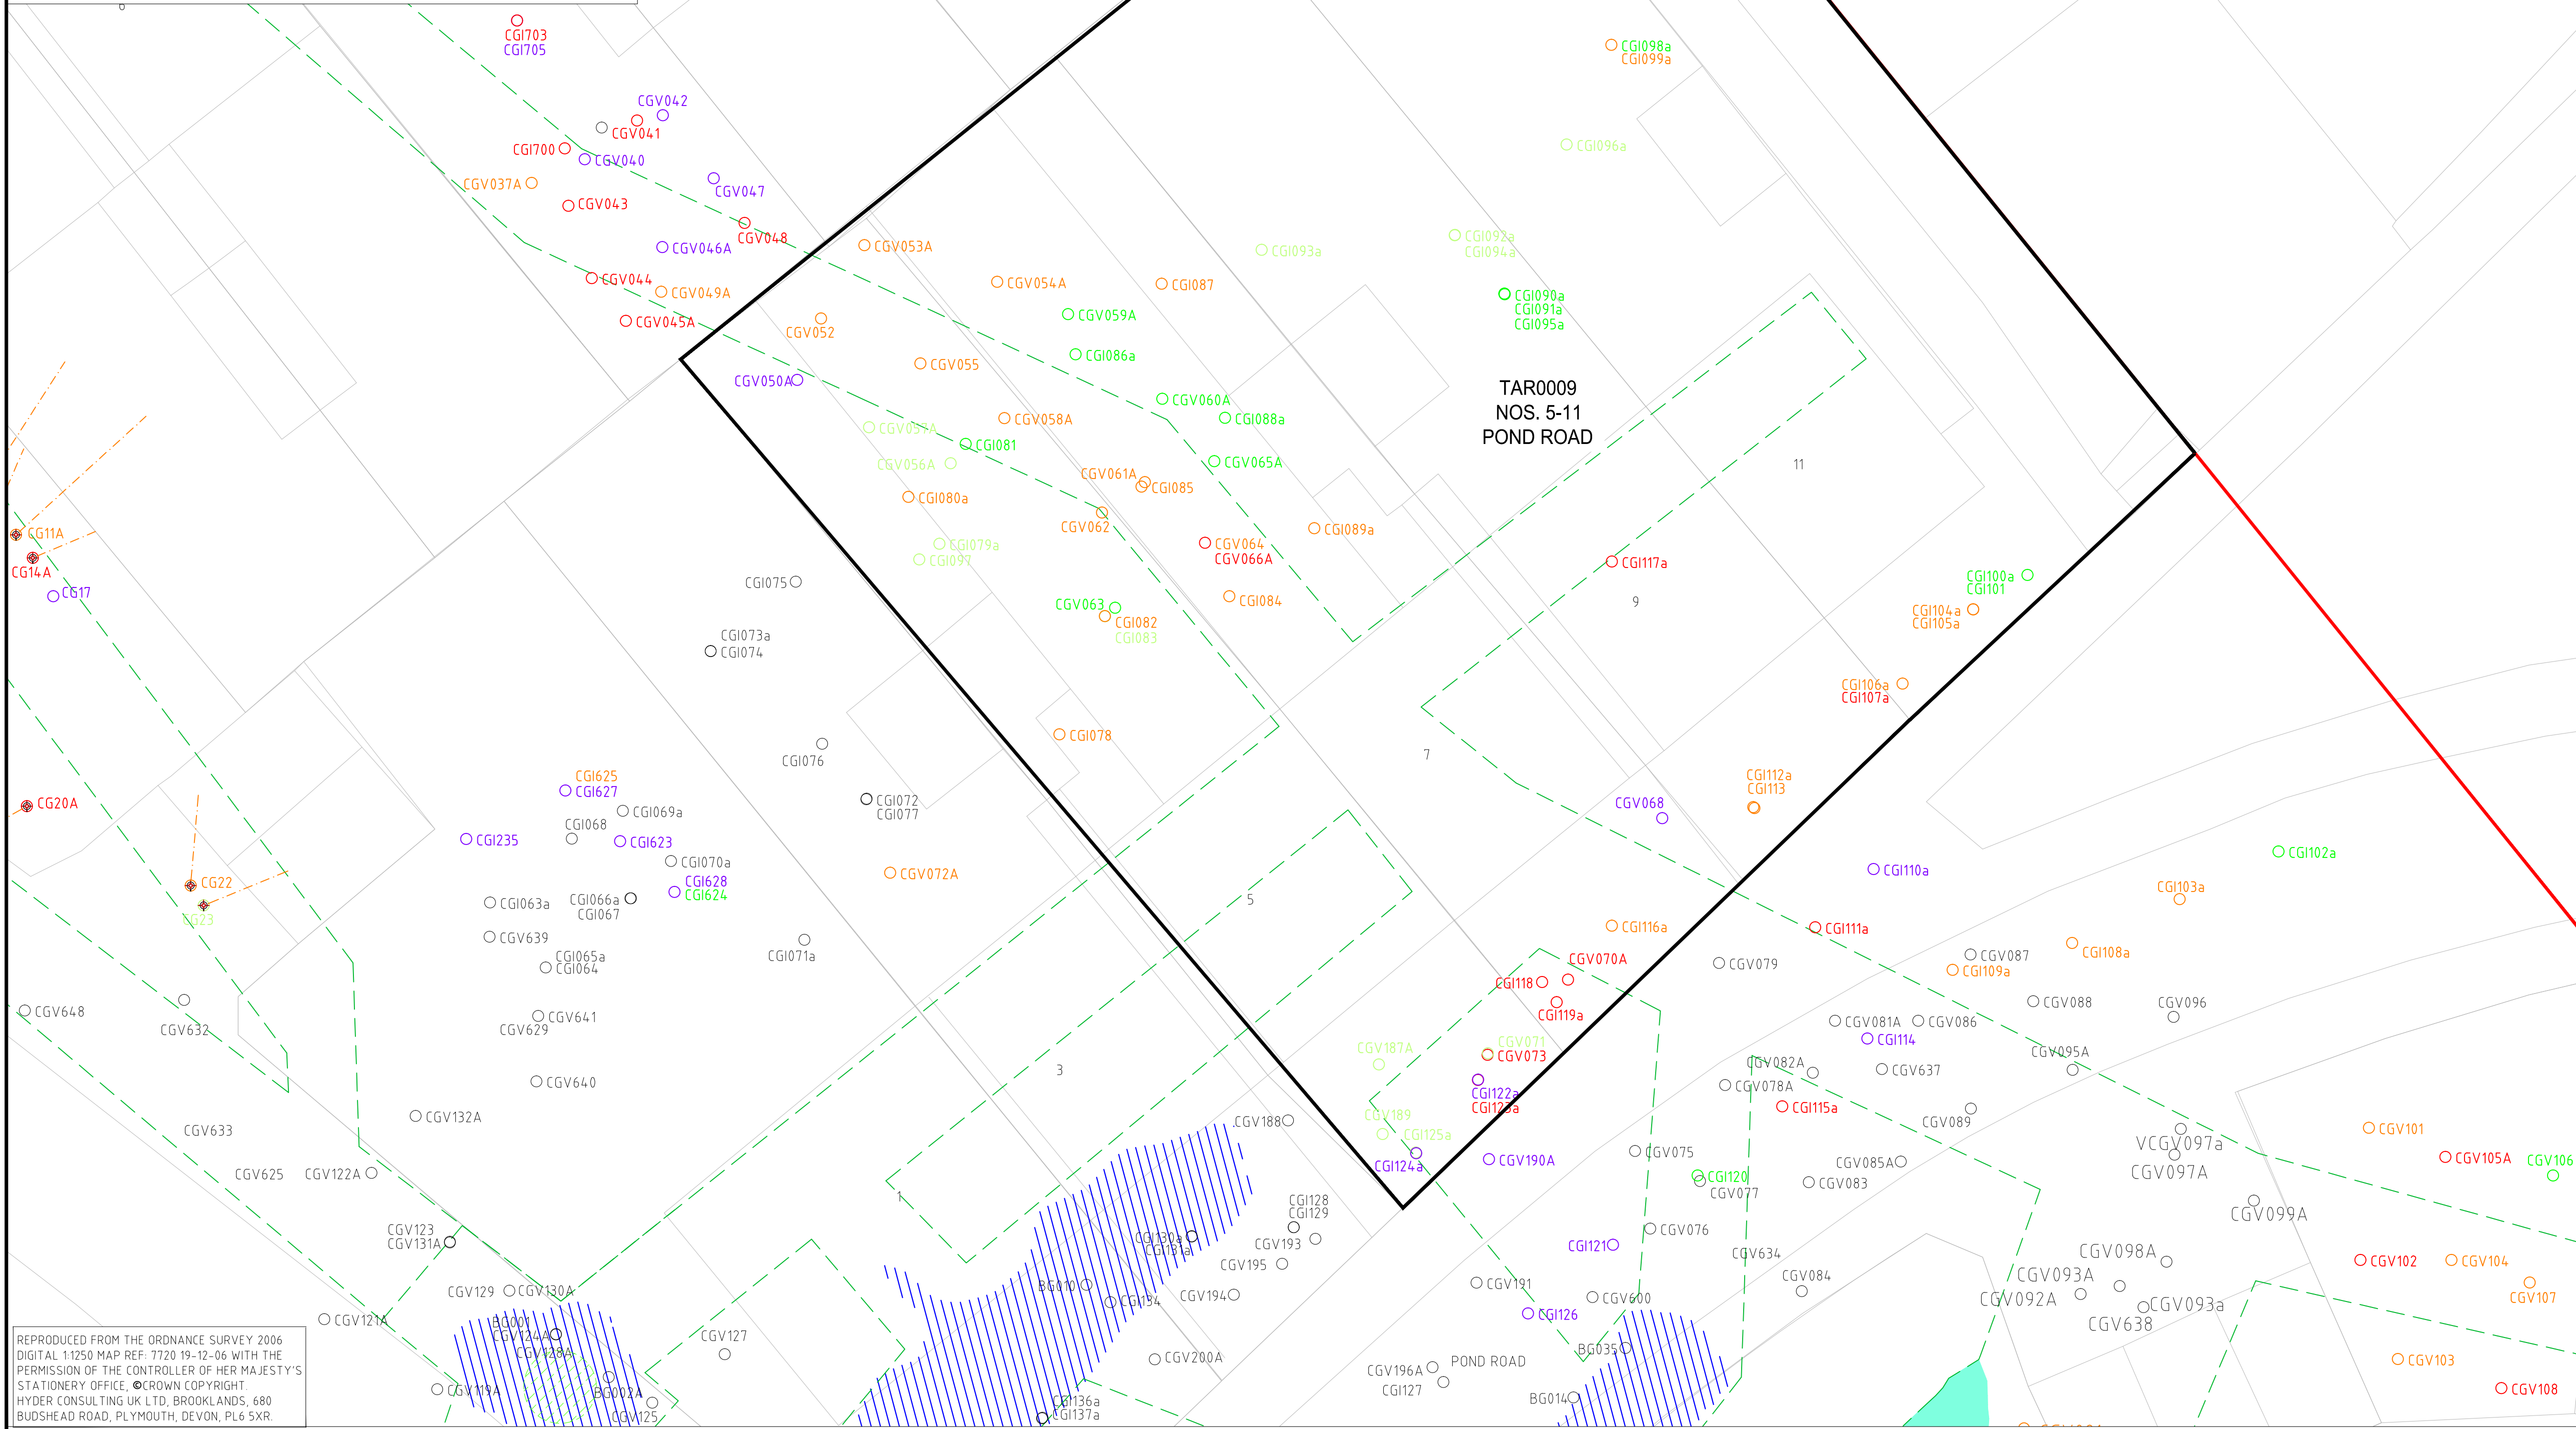
**Drawing TA09-01 – Treatment Area Plan for TAR0009
with Grout Holes**

Treatment at No. 5 Pond Road was initially targeted at a possible junction of mine passages located along the front of the property, adjacent to the area of a previous collapse. Grout holes drilled from the front of the property and Pond Road resulted in high grout volumes indicating treatment of mine galleries in this area (CGV190a (30.7m³), CGI126 (21.2m³) and CGI123 (9.5m³)). Low grout volumes observed in CGV187A (0.95m³) and CGV089 (0.95m³), drilled at a similar time, did not indicate an extension of mine working in the direction of the house.

Treatment was carried out along the back garden of No. 5 due to indications of disturbed ground from the pre-treatment investigations. Higher than normal grout volumes were observed near the back of the garden in CGV053 (4.2m³) and CGV055 (3.6m³). Evidence of an open void was identified during drilling at grout hole CGV050a at depths between 20.5m and 21.7m bgl. The resultant grout volume (167.6m³) confirmed evidence of further mine workings extending towards Meadow Road (see Treatment Area Report TAR0011). Following grouting of CGV050a, a review of treatment at the property was undertaken to assess the potential further mine workings. An additional grid of six inclined compaction grout holes were carried out to complete treatment along the back garden. These were inclined from No. 1 Pond Road (CGI623 – CGI628) with the resultant grout volumes confirming the necessity of further treatment in the area.

A notable reduction in grout volumes was observed at No. 7 compared with No.5 indicating that the mine workings were likely to be in a more collapsed state. Relatively low grout volumes (around 5-6m³) resulted at these properties compared to No.5. The only notable grout volumes were along the front garden of the property (CGV068, 10.2m³) and an inclined compaction grout hole drilled just off the front garden and aimed beneath the property (CGI114 – 24.2m³).

The results of vertical compaction grout holes carried out behind the property suggested evidence of collapsed mine workings in the area along the boundary with No.5 Pond Road (CGV66A, 5.76 m³ and CGV61A (3.28m³)).

Less than half the grout volume (35.2m³) was used below this property when compared to the adjacent property at No. 7 Pond Road (74.5m³) even though approximately the same number of grout holes were drilled. Inclined compaction grout holes aimed beneath the property indicated the potential for mining related weak ground (CGI111 (5.3m³), and CGI112 (4.5m³)) in the front garden. Compaction grout holes in the back garden resulted in volumes between 1.0-2.0m³ (CGI 90 to 95) and did not indicate an extension of the mine workings in this area.

Thirteen inclined grout hole were carried out beneath No. 11 Pond Road from the front and back gardens of the property. No noticeable high grout volumes were observed at the property with grout totals typical of the general volumes in the area.

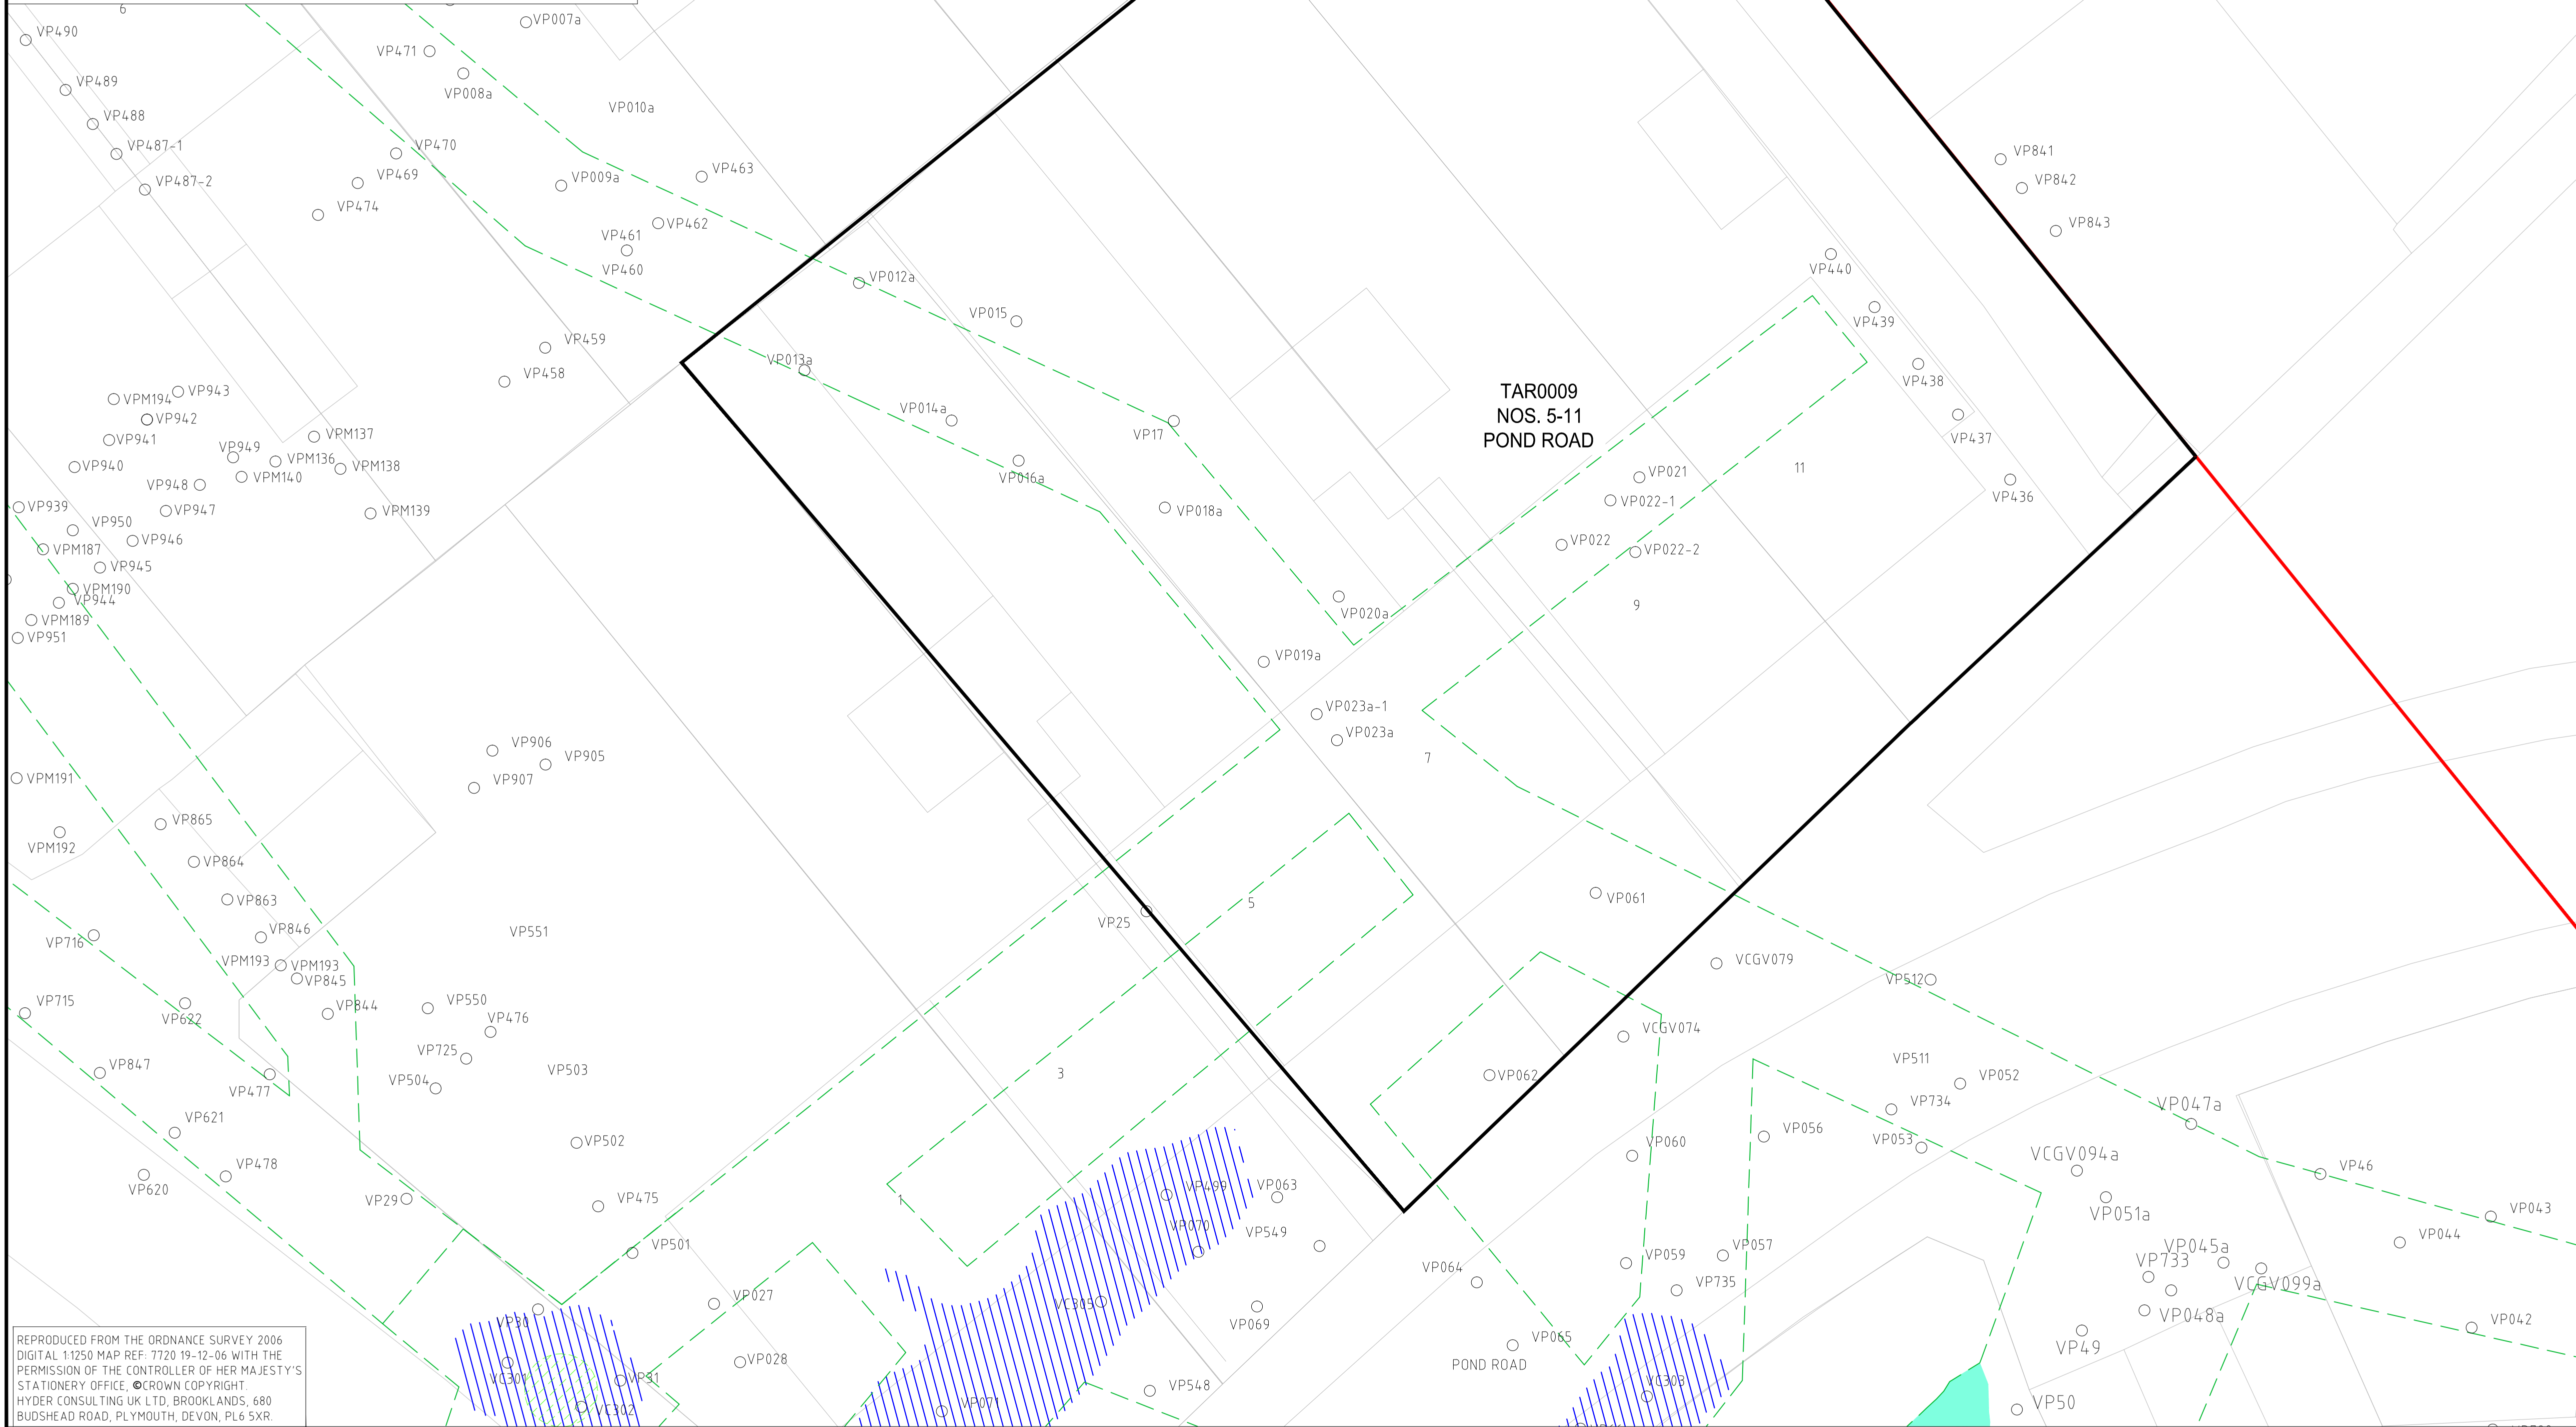
**Drawing TA09-02 – Treatment Area Plan for TAR0009
with Validation Probes**

Dynamic probing carried out to validate the treatment did not find weak ground at the typical depth of the mine found elsewhere. A proposed internal validation probe at the property (VP25), which was moved to the shared alleyway between the property and No. 3 Pond Road, could not penetrate deeper than 18.0m confirming competent ground where the mine could be expected.

Validation probe VP023A carried out inside the property had to be repeated due to an early refusal at 4.9m. The resultant VP023A-1 penetrated to 21.2m and did not reveal weak ground in the zone of the expected mine. The remaining validation probe results following treatment did not indicate any further mining related disturbed ground.

A series of validation dynamic probes were carried out at the property following treatment. Initial validation probes VP021 and VP021-1 both refused early (4.6m and 4.8m respectively) and had to be subsequently repeated. Further dynamic probes located close by managed to penetrate down to below the anticipated mine depth at VP022 and VP022-2, without any indication of weak ground at the interpreted mine depth remaining following the treatment.

Following treatment, a row of (external) validation dynamic probes were carried out along the length of the property to further confirm the termination of the anticipated mine workings at the end of the property. The resultant dynamic probes (VP436 – 440) did not show any mining related disturbed ground, indicating termination of the mine in the area.
