CHALK MINE STABILISATION PROJECT HIGHBARNNS, HEMEL HEMPSTEAD

Treatment Area 11: Nos. 2, 4, 6 and 8 Meadow Road

Report Number: 0013-UA000857-TR-01-TAR-0011

OCTOBER 2015

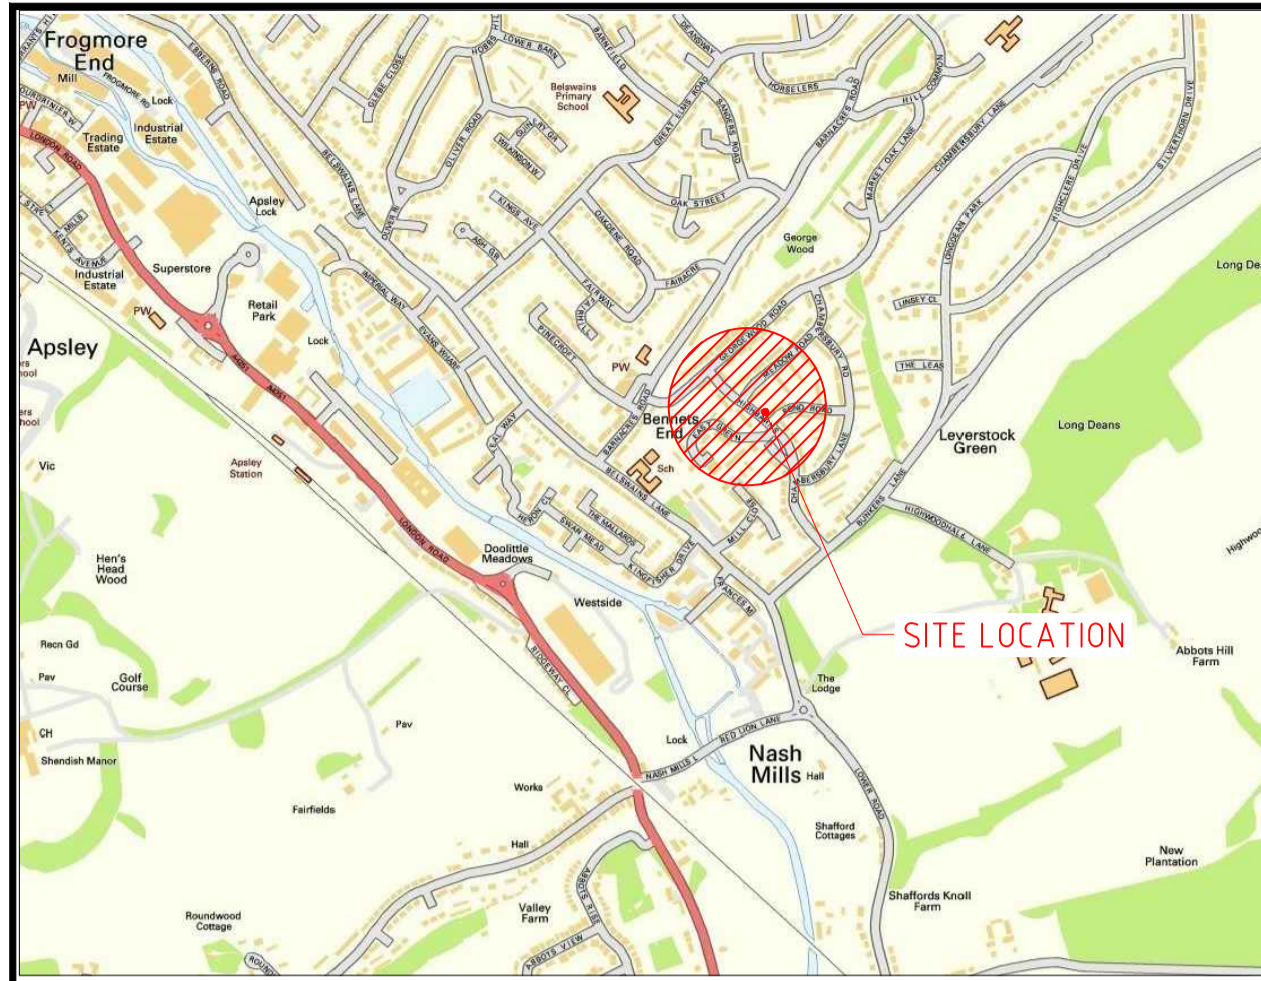
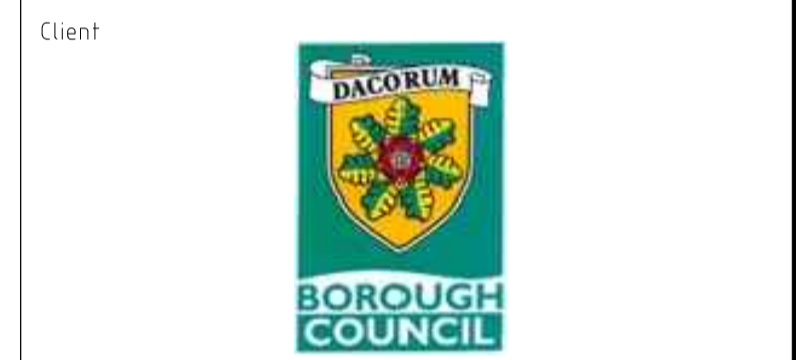
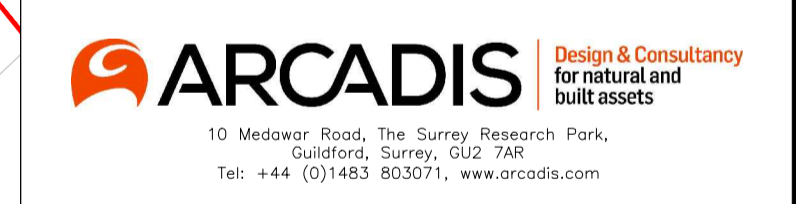
**Drawing TA0011-01 – Treatment Area Plan for TAR0011
with Grout Holes**

This Treatment area, validation probes and extent of grouting work specific to this treatment area are shown on drawings TA0011-01 and 02 in Appendix A.
