CHALK MINE STABILISATION PROJECT HIGHBARNS, HEMEL HEMPSTEAD

Treatment Area 9: Nos. 5, 7, 9 and 11 Pond Road

Report Number: 0013-UA000857-TR-01-TAR-0009

OCTOBER 2015

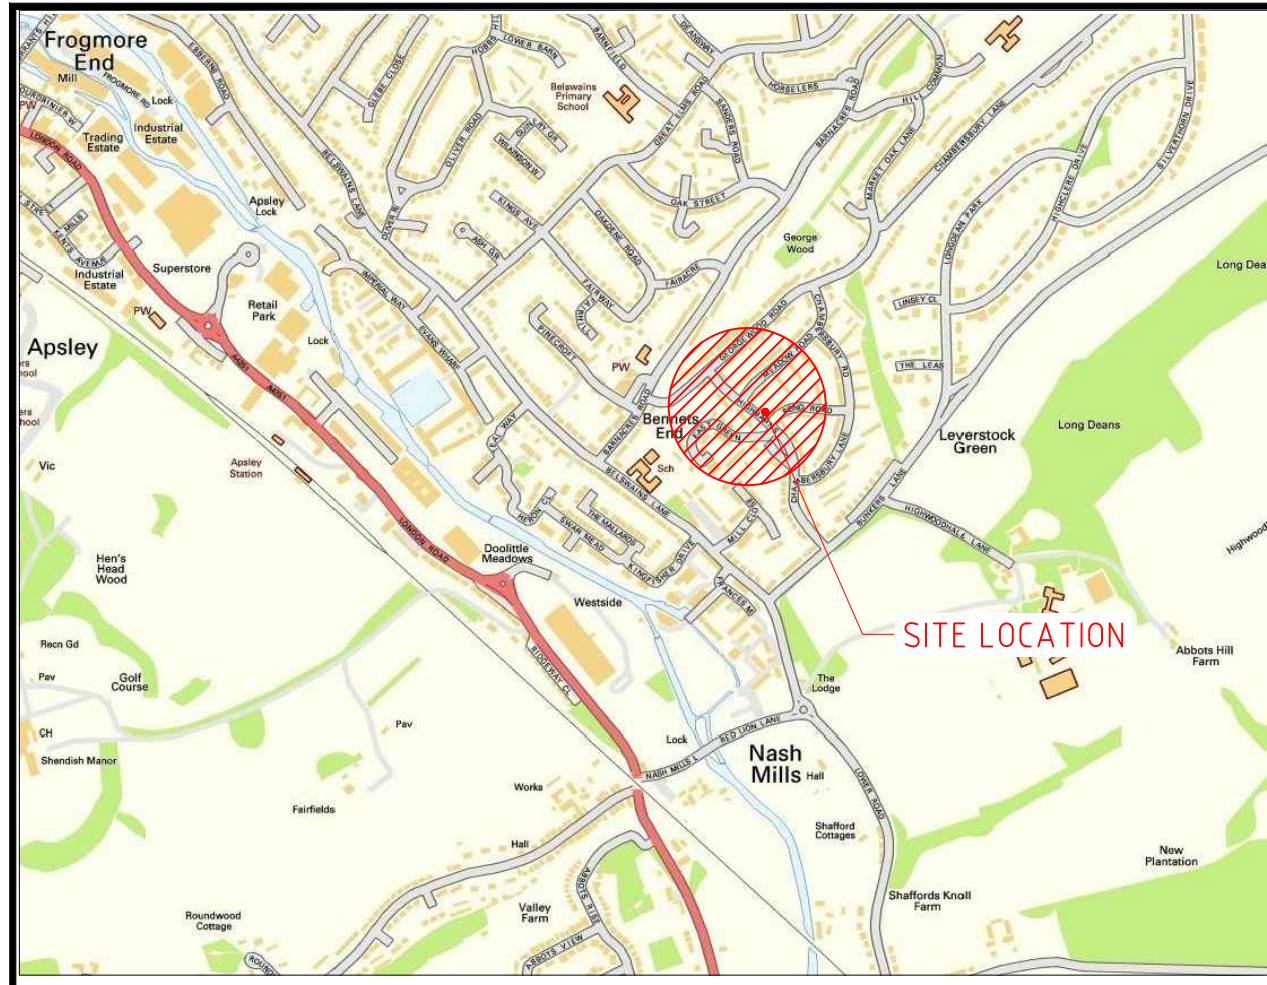
**Drawing TA09-01 – Treatment Area Plan for TAR0009
with Grout Holes**

Treatment at No. 5 Pond Road was initially targeted at a possible junction of mine passages located along the front of the property, adjacent to the area of a previous collapse. Grout holes drilled from the front of the property and Pond Road resulted in high grout volumes indicating treatment of mine galleries in this area (CGV190a (30.7m³), CGI126 (21.2m³) and CGI123 (9.5m³)). Low grout volumes observed in CGV187A (0.95m³) and CGV089 (0.95m³), drilled at a similar time, did not indicate an extension of mine working in the direction of the house.

Treatment was carried out along the back garden of No. 5 due to indications of disturbed ground from the pre-treatment investigations. Higher than normal grout volumes were observed near the back of the garden in CGV053 (4.2m³) and CGV055 (3.6m³). Evidence of an open void was identified during drilling at grout hole CGV050a at depths between 20.5m and 21.7m bgl. The resultant grout volume (167.6m³) confirmed evidence of further mine workings extending towards Meadow Road (see Treatment Area Report TAR0011). Following grouting of CGV050a, a review of treatment at the property was undertaken to assess the potential further mine workings. An additional grid of six inclined compaction grout holes were carried out to complete treatment along the back garden. These were inclined from No. 1 Pond Road (CGI623 – CGI628) with the resultant grout volumes confirming the necessity of further treatment in the area.

A notable reduction in grout volumes was observed at No. 7 compared with No.5 indicating that the mine workings were likely to be in a more collapsed state. Relatively low grout volumes (around 5-6m³) resulted at these properties compared to No.5. The only notable grout volumes were along the front garden of the property (CGV068, 10.2m³) and an inclined compaction grout hole drilled just off the front garden and aimed beneath the property (CGI114 – 24.2m³).

Thirteen inclined grout hole were carried out beneath No. 11 Pond Road from the front and back gardens of the property. No noticeable high grout volumes were observed at the property with grout totals typical of the general volumes in the area.

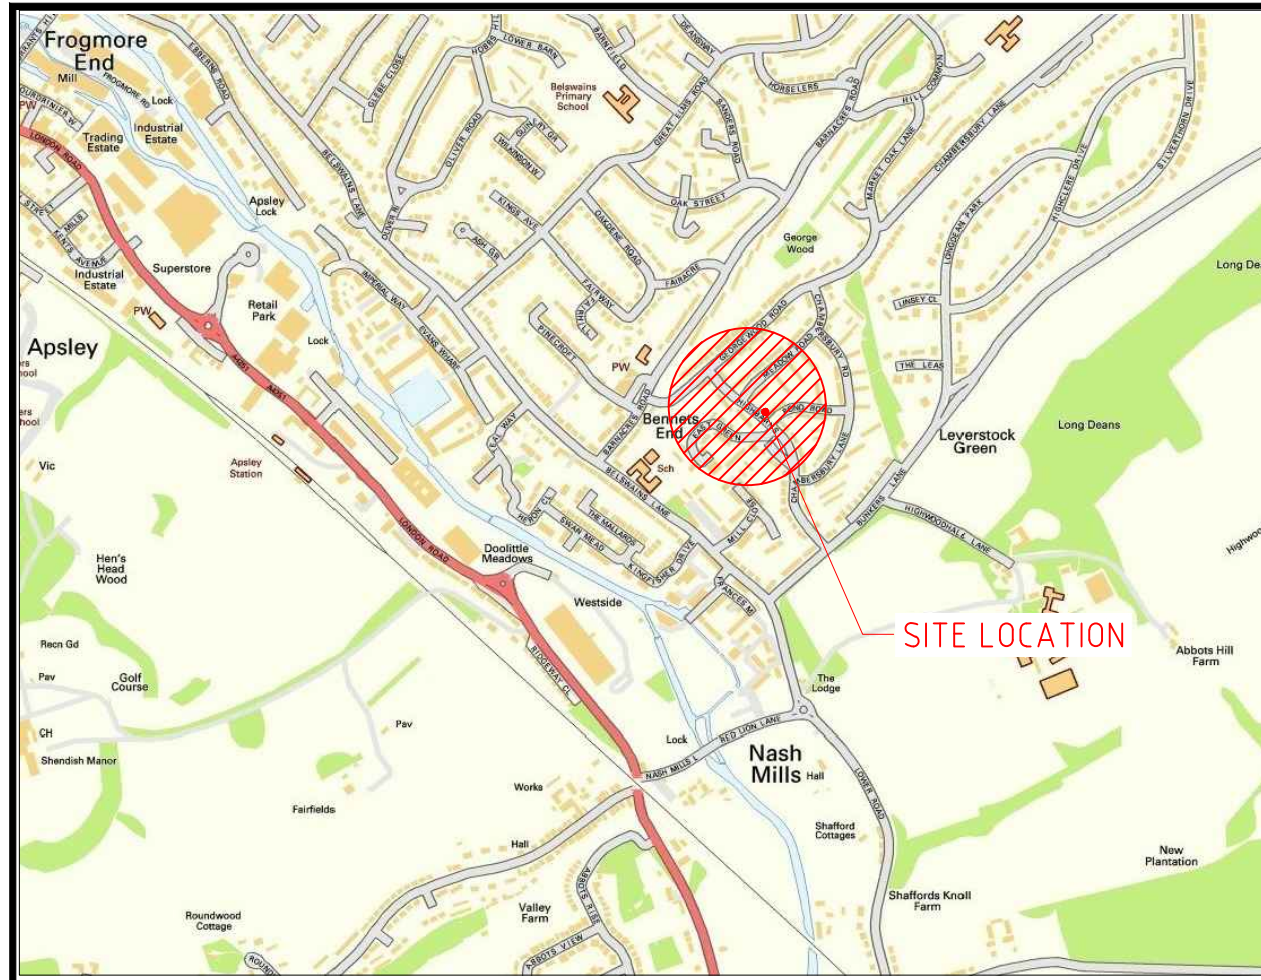
**Drawing TA09-02 – Treatment Area Plan for TAR0009
with Validation Probes**

Dynamic probing carried out to validate the treatment did not find weak ground at the typical depth of the mine found elsewhere. A proposed internal validation probe at the property (VP25), which was moved to the shared alleyway between the property and No. 3 Pond Road, could not penetrate deeper than 18.0m confirming competent ground where the mine could be expected.
